No. 1441914.7

SAMPLE DESCRIPTION:
Flooring Planks: Quick-Step Majestic.

ISO 4760:2022(E) - LAMINATE FLOORING – TOPICAL MOISTURE RESISTANCE – ASSEMBLED JOINT (MODIFIED)

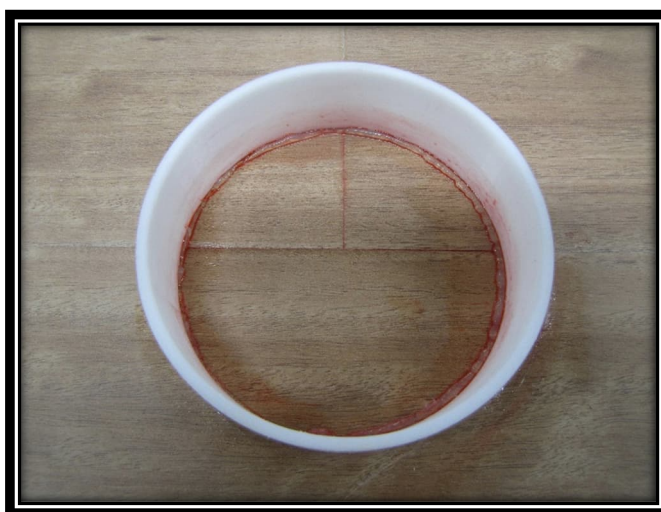
Wet Swell

| | Wet Swell | | |
|---|--|--|--|
| Observations: | No water penetration through the joints. | No water penetration through the joints. | No water penetration through the joints. |

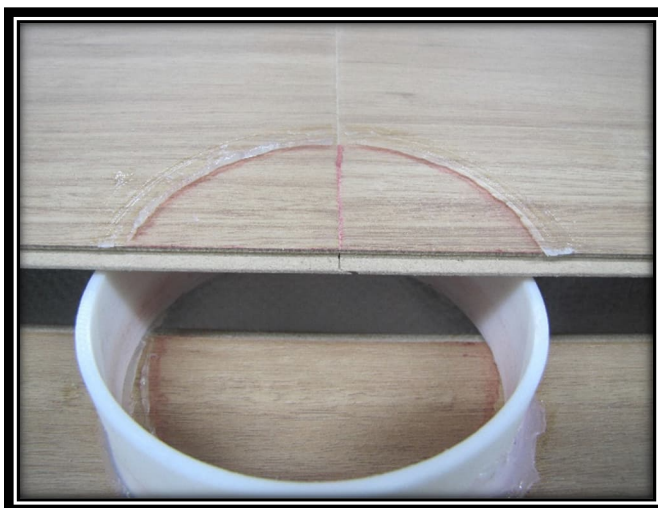
Recovered Swell (Disassembled)

| | Recovered Swell | | |
|---|---|---|---|
| Disassembly Observations: | No evidence of water penetrating the joints. Water remained on the surface of the joints. | No evidence of water penetrating the joints. Water remained on the surface of the joints. | No evidence of water penetrating the joints. Water remained on the surface of the joints. |
