No. 1584548.0

SAMPLE DESCRIPTION:
ReadyFlor Merbau-1 Strip flooring planks assembly
with Selleys Aquadhere Exterior PVA glue applied in
the joints.

RESILIENT FLOOR COVERINGS (BASED ON ISO 4760:2022(E) - LAMINATE FLOORING – TOPICAL MOISTURE RESISTANCE – ASSEMBLED JOINT (MODIFIED))

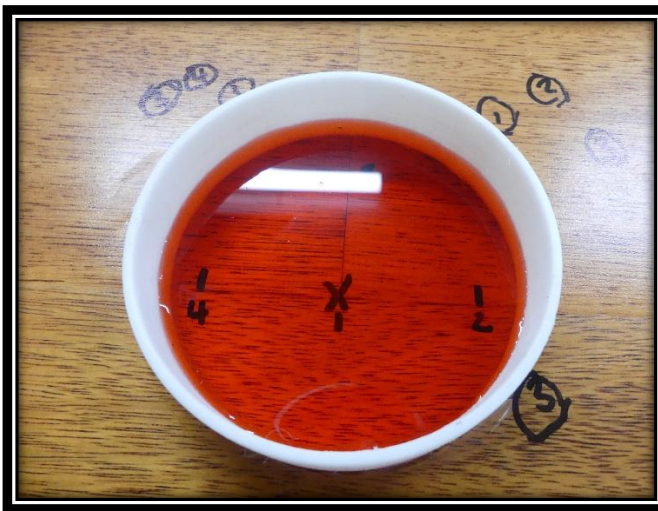
After 24 hrs With Water

Observations:	Specimen 1	Specimen 2	Specimen 3
Migration of water along the upper surface:	No	No	No
Migration of water to the underside:	No	No	No

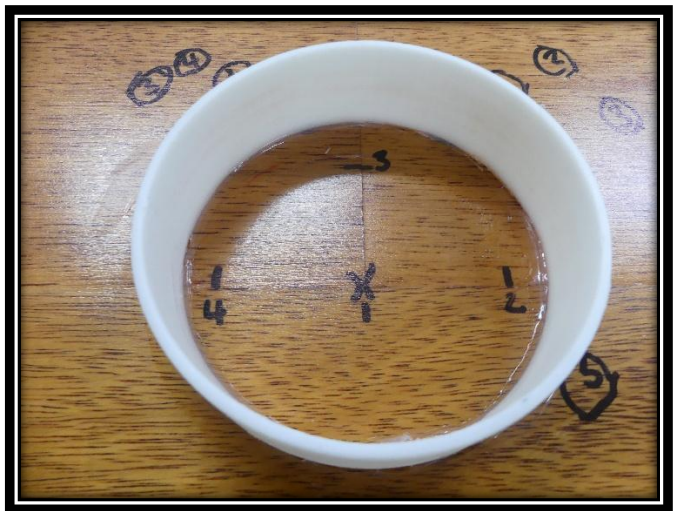
Wet Swell			Recovered Swell		
	Specimen 1	Specimen 2	Specimen 3	Specimen 1	Specimen 2	Specimen 3
Qualitative Ratings (individual results):	2	2	1	1	1	1

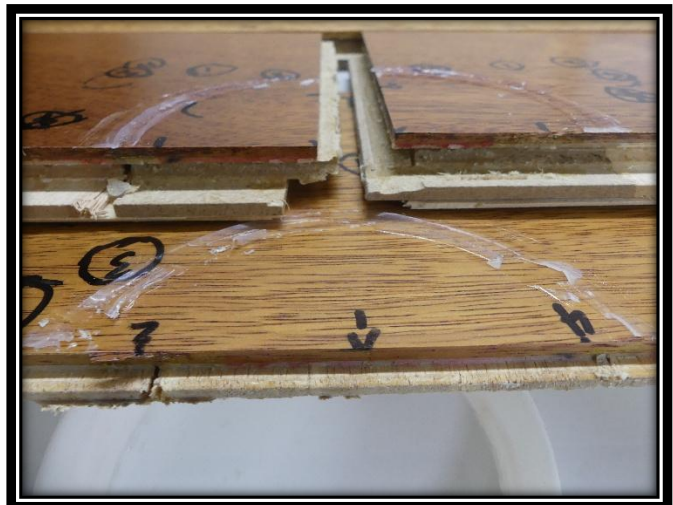
Recovered Swell (Disassembled)

Disassembly Observations:	Specimen 1	Specimen 2	Specimen 3
Migration of water along the upper surface:	Yes	Yes	Yes
Migration of water to the underside:	No	No	No
