**No. 1467244.8**

SAMPLE DESCRIPTION:  
Flooring Planks – CLIX XL Code CXL061.

**ISO 4760:2022(E) - LAMINATE FLOORING – TOPICAL MOISTURE RESISTANCE – ASSEMBLED JOINT (MODIFIED)**

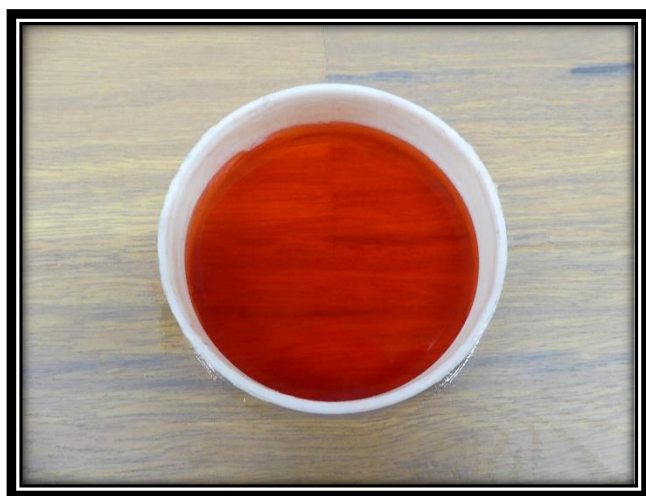
After 24 hrs With Water

100 mls of dye solution was applied onto the sample surface. It was poured into a cylinder 100mm diameter placed in the centre of the sample at the "T joint." Sealant was used at the plank/cylinder interface to avoid leakage.

The sample was left at 20°C, 65% Relative Humidity room conditions for 24 hours after the dye was added and then examined for dye penetration through the backing (not 23°C, 50% RH as stated in the method).

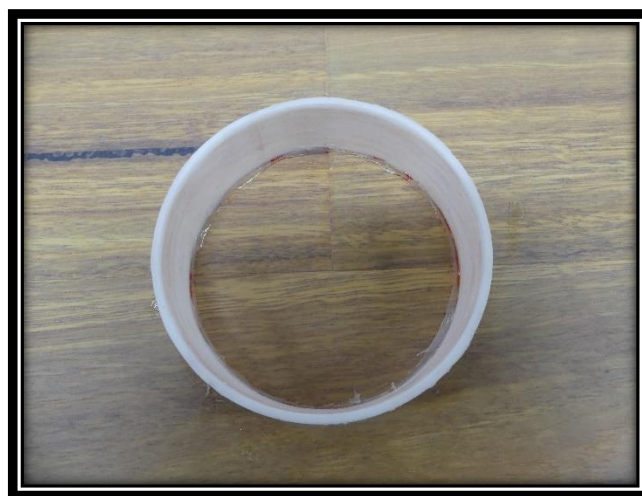
Wet Swell

Wet Swell			Recovered Swell		
	Specimen 1	Specimen 2	Specimen 3	Specimen 1	Specimen 2	Specimen 3
Qualitative Ratings (individual results):	1	1	1	1	1	1

Observations:	Specimen 1	Specimen 2	Specimen 3
Migration of water along the upper surface:	No	No	No
Migration of water to the underside:	No	No	No

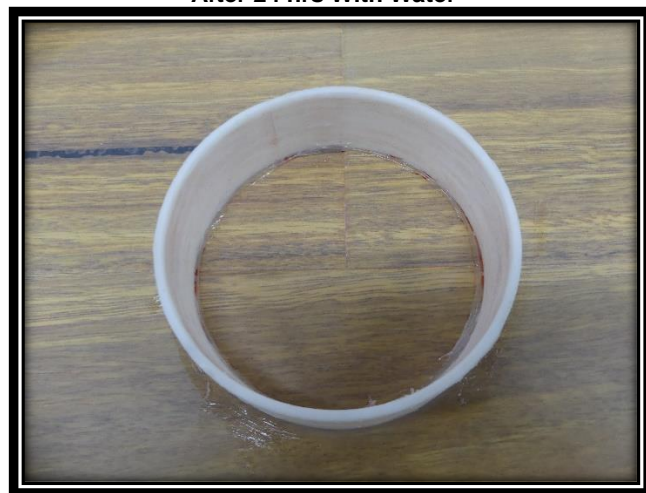
Recovered Swell

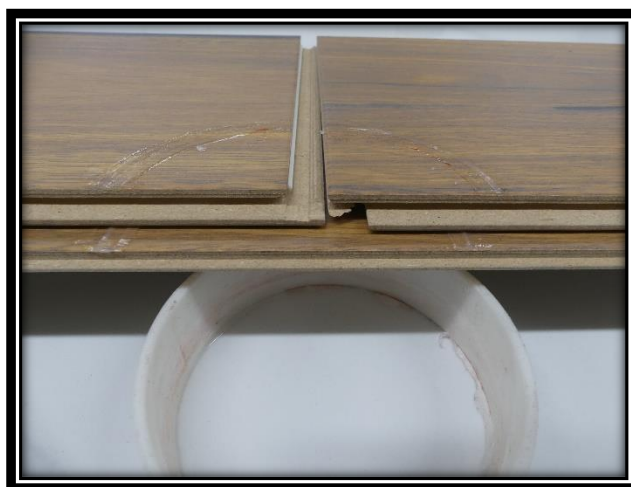
Recovered Swell (Disassembled)

Disassembly Observations:	Specimen 1	Specimen 2	Specimen 3
Migration of water along the upper surface:	No	No	No
Migration of water to the underside:	No	No	No
