**No. 1425236.5B**

SAMPLE DESCRIPTION:  
Flooring sample – PERGO Sensation Modern Plank  
Laminate (L0339-04289).

**ISO 4760:2022(E) - LAMINATE FLOORING – TOPICAL MOISTURE RESISTANCE – ASSEMBLED JOINT (MODIFIED)**

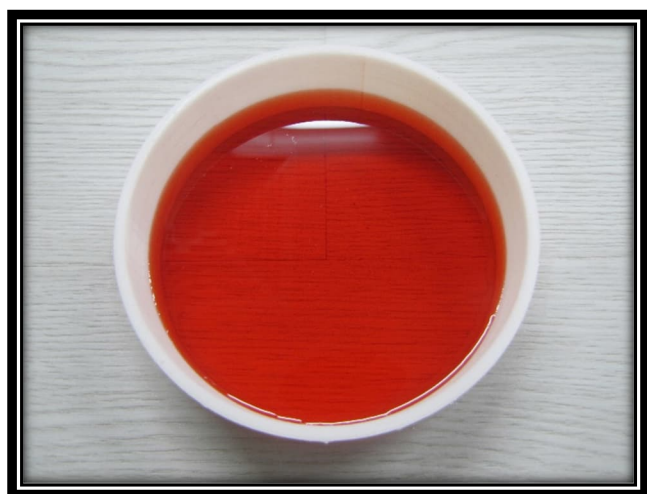
**24 Hrs with Water**

100 mls of dye solution was applied onto the sample surface. It was poured into a cylinder 100mm diameter placed in the centre of the sample at the "T joint." Sealant was used at the plank/cylinder interface to avoid leakage.

The sample was left at 20°C, 65% Relative Humidity room conditions for 24 hours after the dye was added and then examined for dye penetration through the backing (not 23°C, 50% RH as stated in the method).

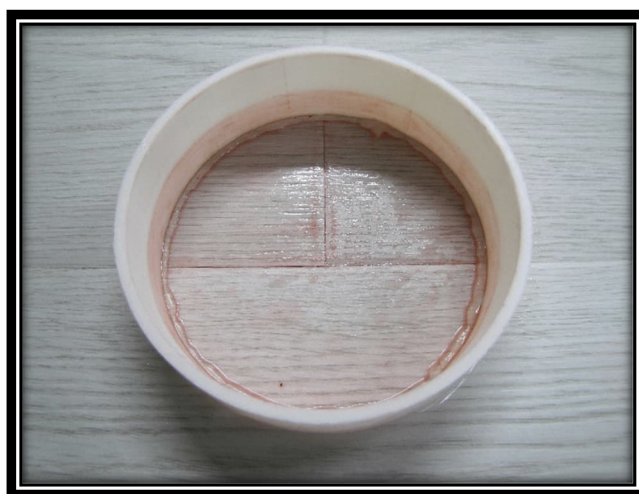
**Wet Swell**

Wet Swell		
	Specimen 1	Specimen 2	Specimen 3
Observations:	No Water Penetration through the joints.	No Water Penetration through the joints.	No Water Penetration through the joints.

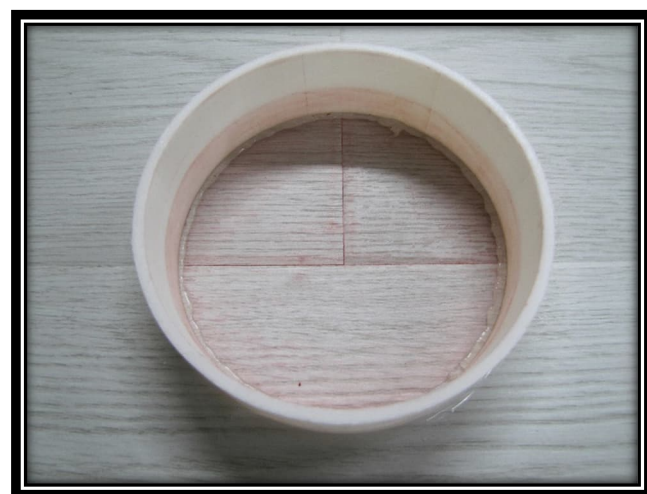
**Recovered Swell**
