No. 1443184.5

SAMPLE DESCRIPTION:
Flooring Planks: Pergo Laminate – Sensation Wide/Long.

ISO 4760:2022(E) - LAMINATE FLOORING – TOPICAL MOISTURE RESISTANCE – ASSEMBLED JOINT (MODIFIED)

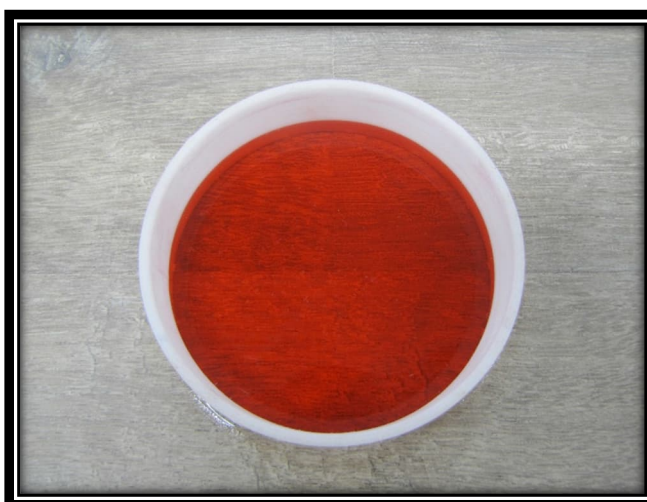
24 hrs With Water

Weights were placed on the outer corners of the test specimens to keep the samples flat throughout the test procedure. 100 mls of dye solution was applied onto the sample surface. It was poured into a cylinder 100mm diameter placed in the centre of the sample at the "T joint." Sealant was used at the plank/cylinder interface to avoid leakage.

The sample was placed on white paper towels prior to testing to enable detection of any dye penetration through the joints. The sample was left at 20°C, 65% Relative Humidity room conditions for 24 hours after the dye was added and then examined for dye penetration through the backing (not 23°C, 50% RH as stated in the method).

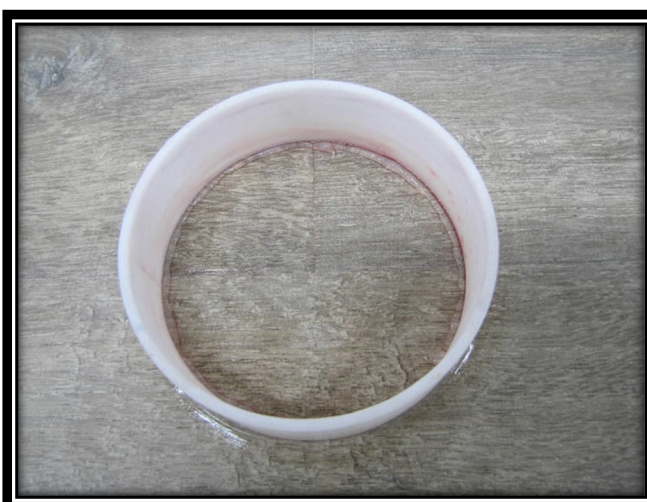
Wet Swell

Wet Swell			Recovered Swell		
	Specimen 1	Specimen 2	Specimen 3	Specimen 1	Specimen 2	Specimen 3
Qualitative Ratings (individual results):	1	1	1	1	1	1

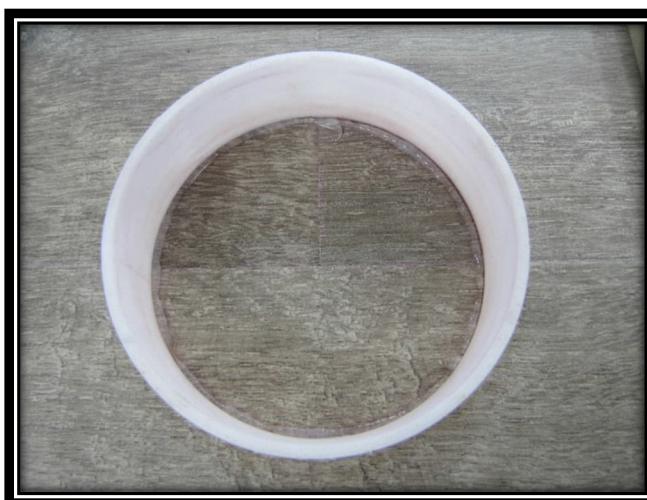
Recovered Swell

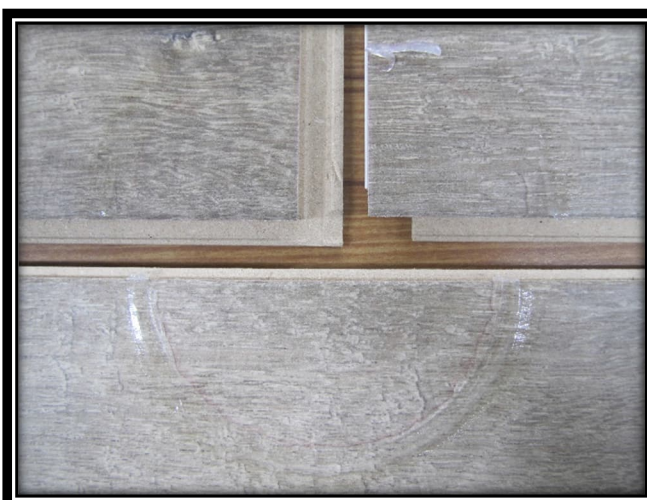
Recovered Swell (Disassembled)

Disassembly Observations:	Specimen 1	Specimen 2	Specimen 3
Migration of water along the upper surface:	No	No	No
Migration of water to the underside:	No	No	No
