**No. 1633135.7**

SAMPLE DESCRIPTION:  
Pergo 8mm laminate flooring planks assembly – Visby  
Linen Grey Oak

**ISO 4760:2022(E) - LAMINATE FLOORING – TOPICAL MOISTURE RESISTANCE – ASSEMBLED JOINT (MODIFIED)**

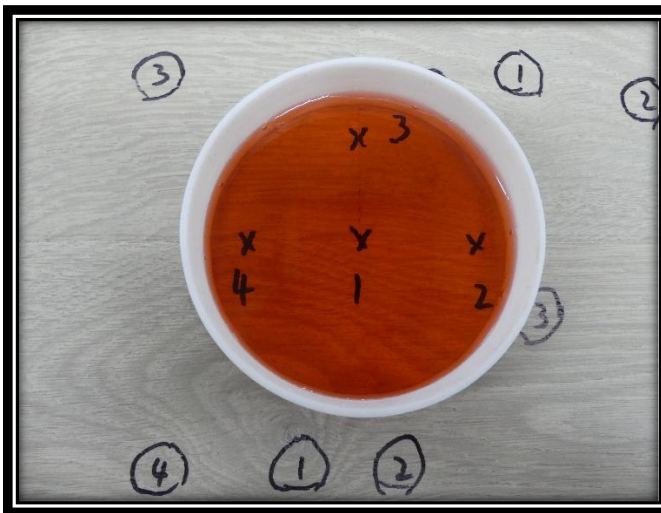
After 24 hrs With Water

100 mls of dye solution was applied onto the sample surface. It was poured into a cylinder 100mm diameter placed in the centre of the sample at the "T joint." Sealant was used at the plank/cylinder interface to avoid leakage.

The sample was left at 20°C, 65% Relative Humidity room conditions for 24 hours after the dye was added and then examined for dye penetration through the backing (not 23°C, 50% RH as stated in the method).

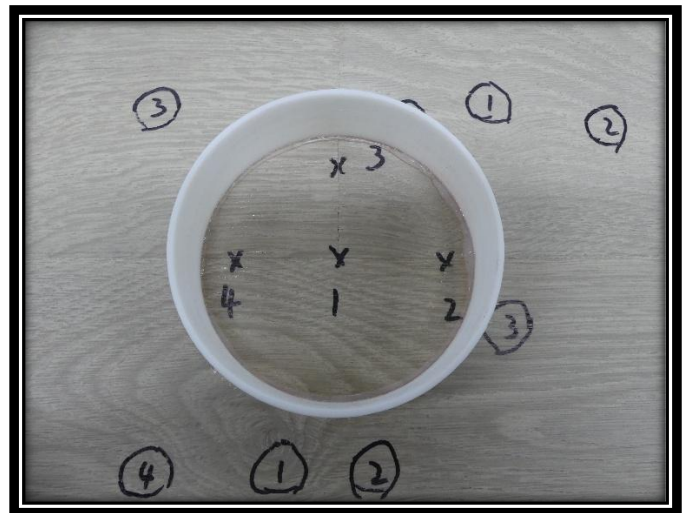
Wet Swell

Quantitative measurements are used to calculate surface swell in mm (within 15 minutes after water removal) and recovery swell (24 hours after removal of water).

| Quantitative Results: | Wet Swell (mm) | | | Recovered Swell (mm) | | |
|---|---|---|---|---|---|---|
| Final Average Results<br>(Positions 2 to 4) | 0.33 | 0.37 | 0.16 | 0.10 | 0.15 | 0.12 |
| Final Results (Position 1) | 0.35 | 0.46 | 0.43 | 0.22 | 0.29 | 0.14 |

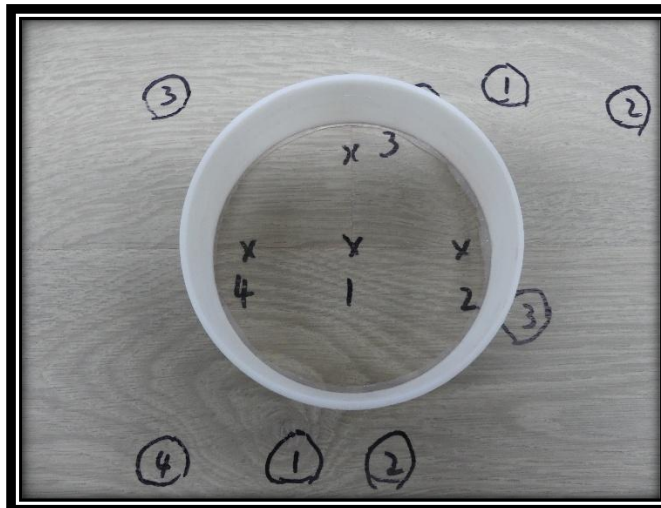
Recovered Swell

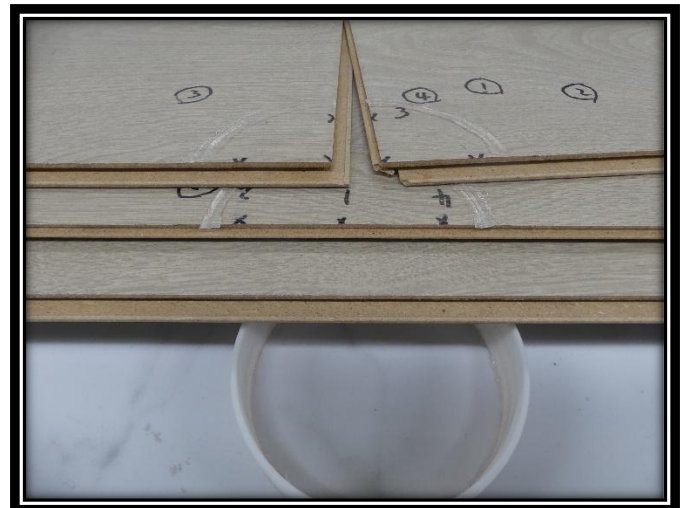
Recovered Swell (Disassembled)

| Disassembly Observations: | Specimen 1 | Specimen 2 | Specimen 3 |
| Migration of water along the upper surface: | No | No | No |
| Migration of water to the underside: | No | No | No |
