No. 1435596.0

SAMPLE DESCRIPTION:
Flooring Planks:
Quick-Step Amato – Engineered Timber.

ISO 4760:2022(E) - LAMINATE FLOORING – TOPICAL MOISTURE RESISTANCE – ASSEMBLED JOINT (MODIFIED)

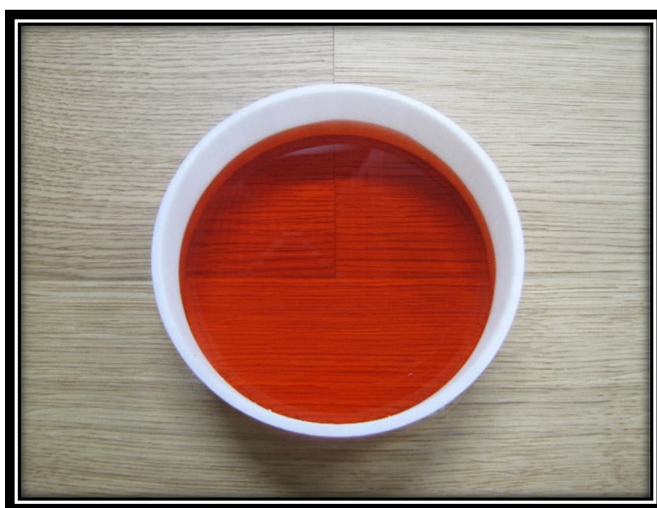
24 hrs With Water

Weights were placed on the outer corners of the test specimens to keep the samples flat throughout the test procedure. 100 mls of dye solution was applied onto the sample surface. It was poured into a cylinder 100mm diameter placed in the centre of the sample at the "T joint." Sealant was used at the plank/cylinder interface to avoid leakage.

The sample was placed on white paper towels prior to testing to enable detection of any dye penetration through the joints. The sample was left at 20°C, 65% Relative Humidity room conditions for 24 hours after the dye was added and then examined for dye penetration through the backing (not 23°C, 50% RH as stated in the method).

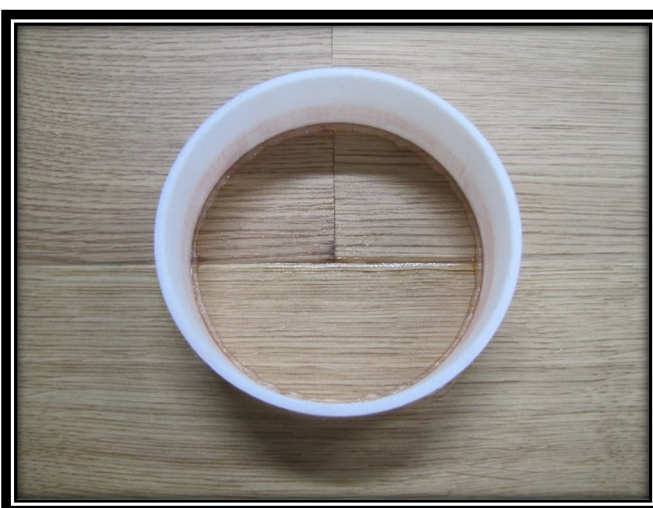
Wet Swell

Wet Swell		
	Specimen 1	Specimen 2	Specimen 3
Observations:	No water penetration through the joints.	No water penetration through the joints.	No water penetration through the joints.

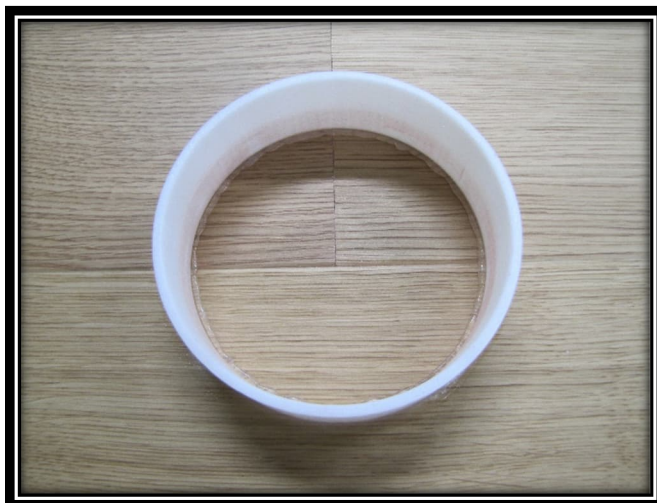
Recovered Swell

Recovered Swell		
	Specimen 1	Specimen 2	Specimen 3
Disassembly Observations:	No evidence of water penetrating the joints. Water remained on the surface of the joints.	No evidence of water penetrating the joints. Water remained on the surface of the joints.	No evidence of water penetrating the joints. Water remained on the surface of the joints.

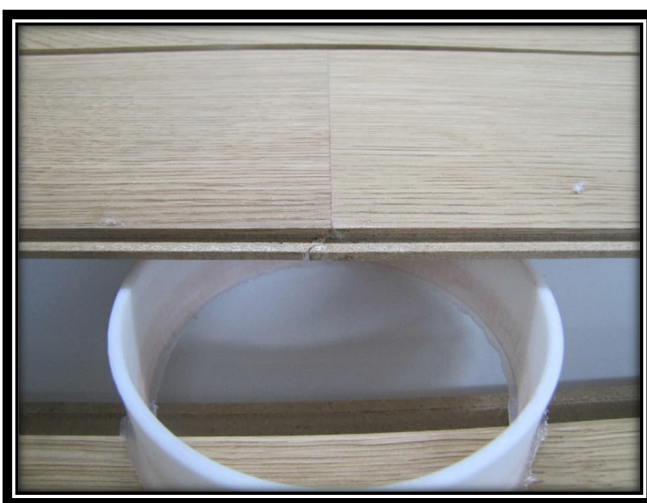
Recovered Swell (Disassembled)
