**No. 1425236.5D**

SAMPLE DESCRIPTION:  
Flooring sample – Quick Step Classic Laminate (CLM 1405).

**ISO 4760:2022(E) - LAMINATE FLOORING – TOPICAL MOISTURE RESISTANCE – ASSEMBLED JOINT (MODIFIED)**

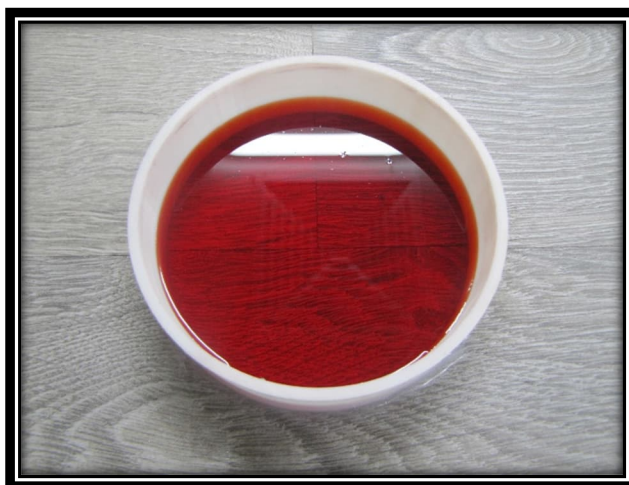
24 Hrs with Water

100 mls of dye solution was applied onto the sample surface. It was poured into a cylinder 100mm diameter placed in the centre of the sample at the "T joint." Sealant was used at the plank/cylinder interface to avoid leakage.

The sample was left at 20°C, 65% Relative Humidity room conditions for 24 hours after the dye was added and then examined for dye penetration through the backing (not 23°C, 50% RH as stated in the method).

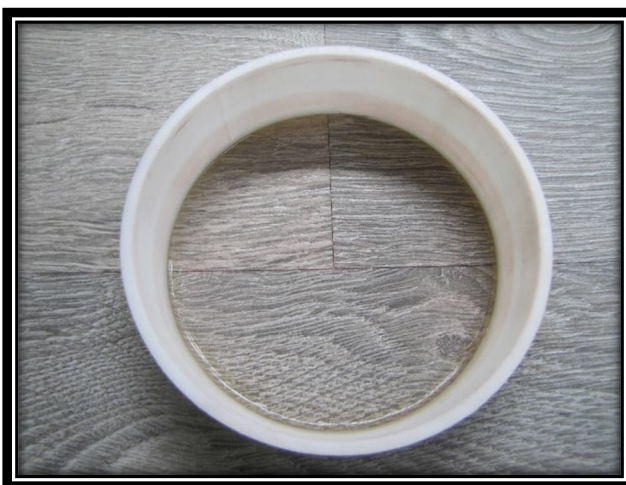
Wet Swell

Wet Swell		
	Specimen 1	Specimen 2	Specimen 3
Observations:	No Water Penetration through the joints.	No Water Penetration through the joints.	No Water Penetration through the joints.

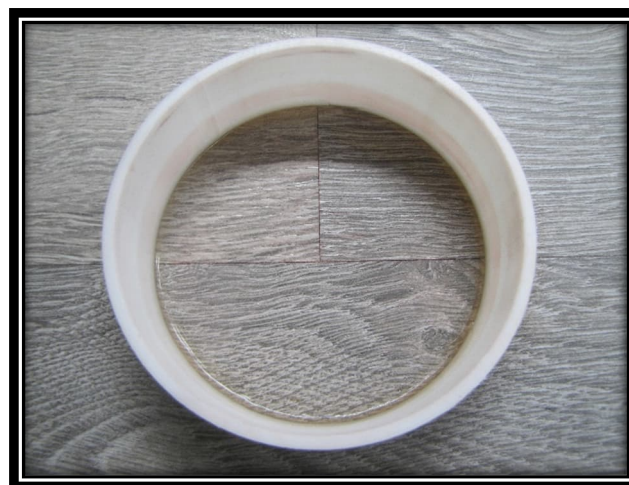
Recovered Swell

Wet Swell			Recovered Swell		
	Specimen 1	Specimen 2	Specimen 3	Specimen 1	Specimen 2	Specimen 3
Qualitative Ratings (individual results):	1	1	1	1	1	1
