No. 1443187.8

SAMPLE DESCRIPTION:
Flooring Planks: Quick-Step Laminate - Eligna.

ISO 4760:2022(E) - LAMINATE FLOORING – TOPICAL MOISTURE RESISTANCE – ASSEMBLED JOINT (MODIFIED)

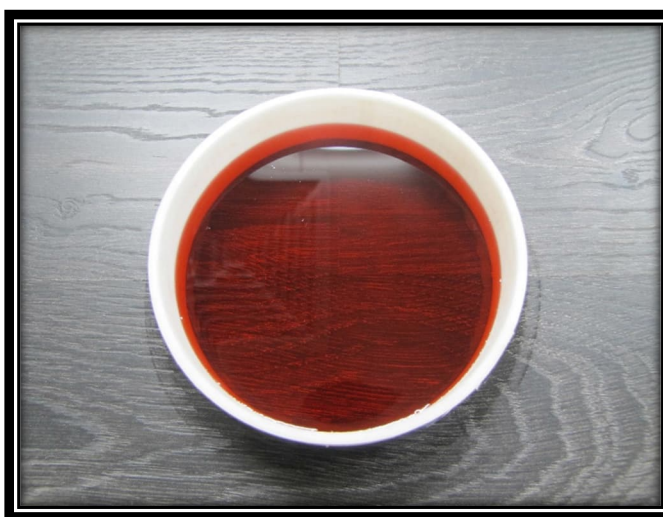
24 hrs With Water

Weights were placed on the outer corners of the test specimens to keep the samples flat throughout the test procedure. 100 mls of dye solution was applied onto the sample surface. It was poured into a cylinder 100mm diameter placed in the centre of the sample at the "T joint." Sealant was used at the plank/cylinder interface to avoid leakage.

The sample was placed on white paper towels prior to testing to enable detection of any dye penetration through the joints. The sample was left at 20°C, 65% Relative Humidity room conditions for 24 hours after the dye was added and then examined for dye penetration through the backing (not 23°C, 50% RH as stated in the method).

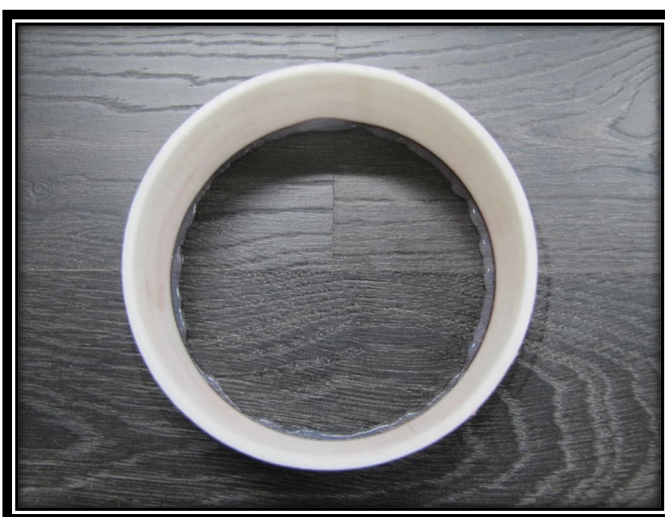
Wet Swell

Wet Swell			Recovered Swell		
	Specimen 1	Specimen 2	Specimen 3	Specimen 1	Specimen 2	Specimen 3
Qualitative Ratings (individual results):	1	1	1	1	1	1

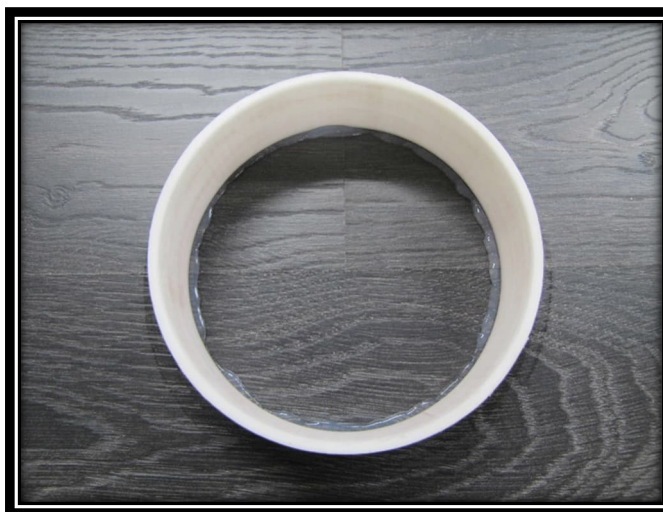
Recovered Swell

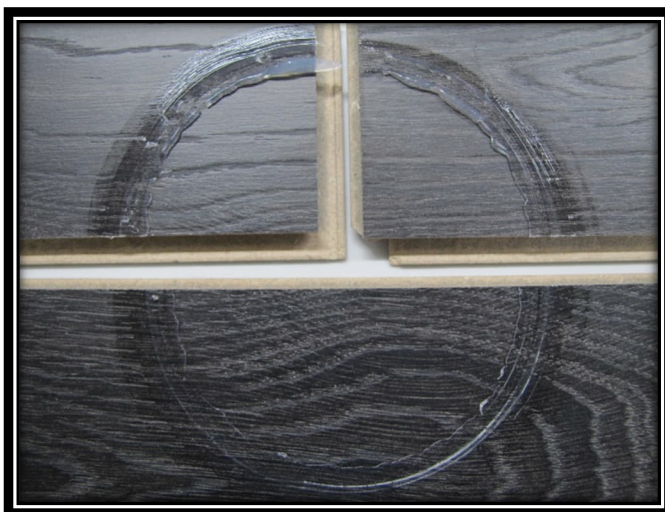
Recovered Swell (Disassembled)

Disassembly Observations:	Specimen 1	Specimen 2	Specimen 3
Migration of water along the upper surface:	No	No	No
Migration of water to the underside:	No	No	No
