SAMPLE DESCRIPTION:
Quick-Step Herringbone laminate flooring planks
assembly.

ISO 4760:2022(E) - LAMINATE FLOORING – TOPICAL MOISTURE RESISTANCE – ASSEMBLED JOINT (MODIFIED)

No. 1601426.8

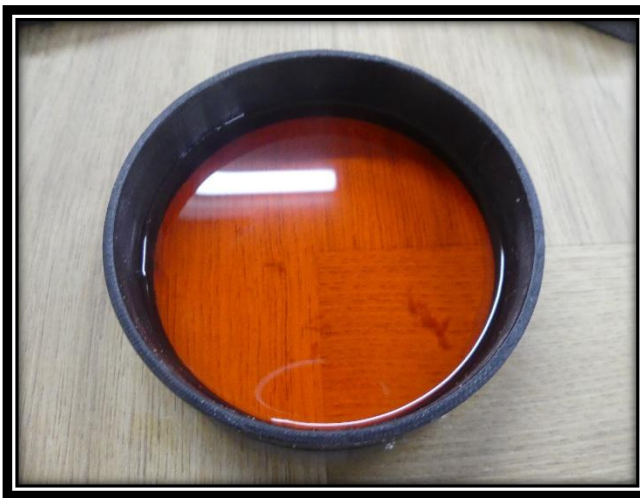
After 24 hrs With Water

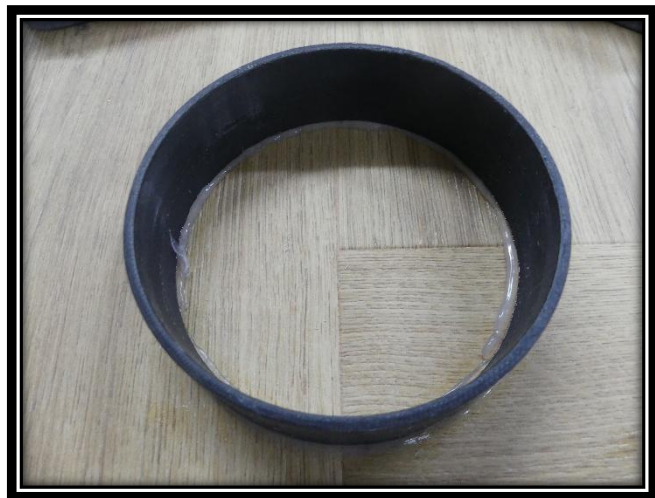
Wet Swell

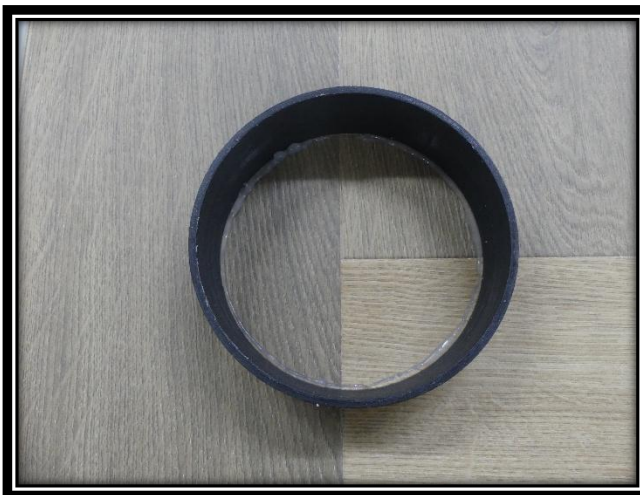
Recovered Swell

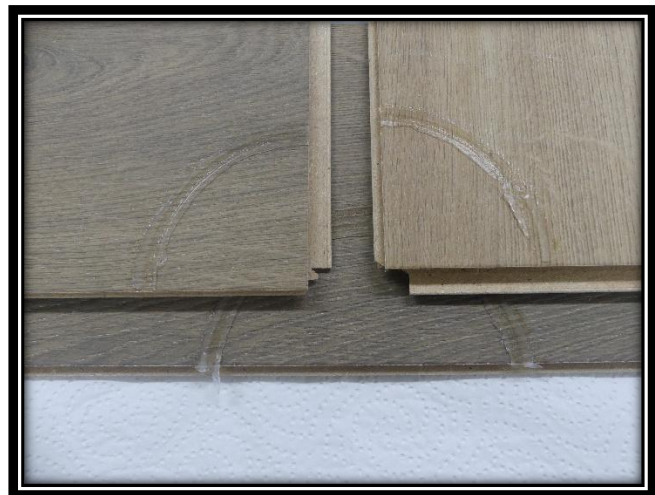
Recovered Swell (Disassembled)

Disassembly Observations:	Specimen 1	Specimen 2	Specimen 3
Migration of water along the upper surface:	No	No	No
Migration of water to the underside:	No	No	No
