No. 1425236.5A

SAMPLE DESCRIPTION:
Flooring sample – Quick Step Impressive Laminate (IM1849).

ISO 4760:2022(E) - LAMINATE FLOORING – TOPICAL MOISTURE RESISTANCE – ASSEMBLED JOINT (MODIFIED)

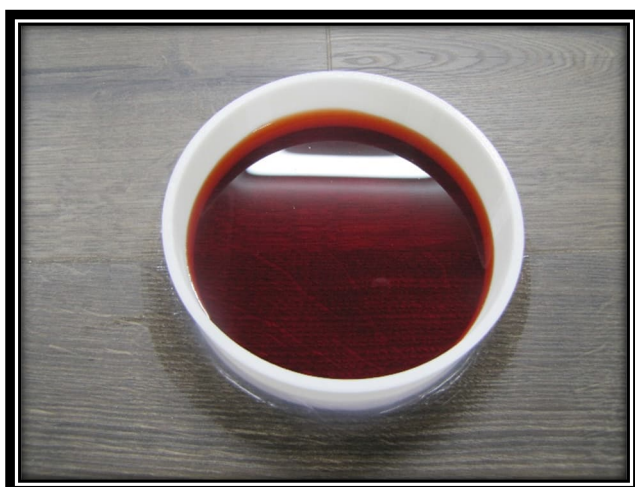
24 Hrs with Water

100 mls of dye solution was applied onto the sample surface. It was poured into a cylinder 100mm diameter placed in the centre of the sample at the "T joint." Sealant was used at the plank/cylinder interface to avoid leakage.

The sample was left at 20°C, 65% Relative Humidity room conditions for 24 hours after the dye was added and then examined for dye penetration through the backing (not 23°C, 50% RH as stated in the method).

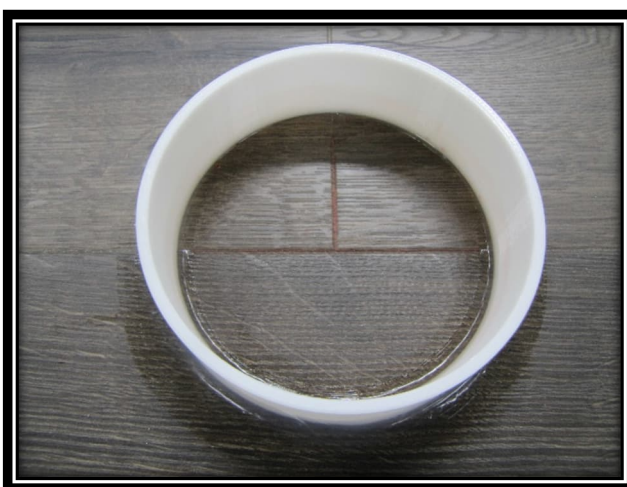
Wet Swell

Wet Swell		
	Specimen 1	Specimen 2	Specimen 3
Observations:	No Water Penetration through the joints.	No Water Penetration through the joints.	No Water Penetration through the joints.

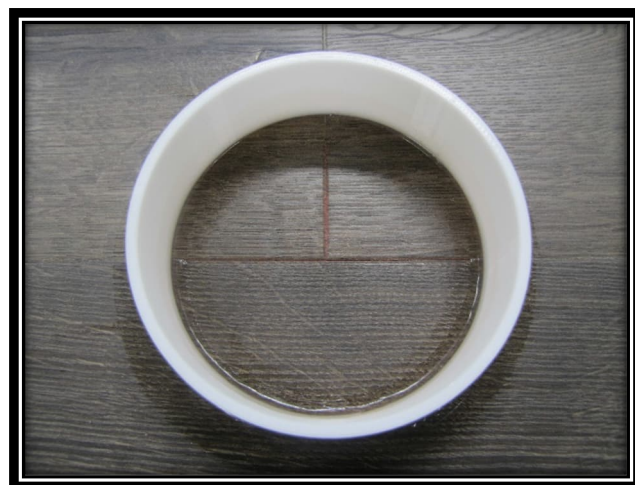
Recovered Swell

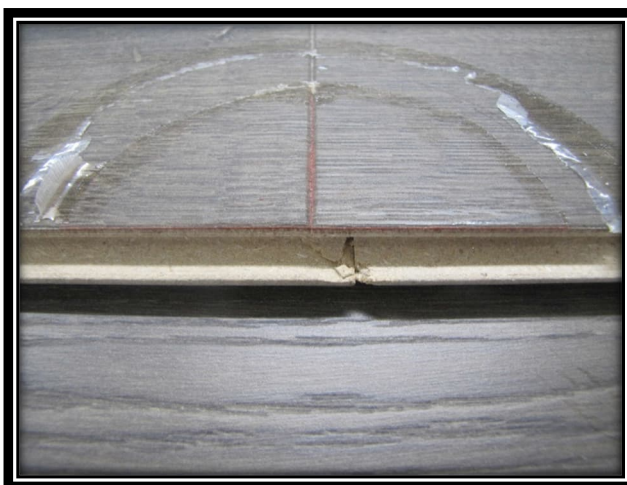
Recovered Swell (Disassembled)

Recovered Swell		
	Specimen 1	Specimen 2	Specimen 3
Disassembly Observations:	No evidence of water penetrating the joints. Water remained on the surface of the joints.	No evidence of water penetrating the joints. Water remained on the surface of the joints.	No evidence of water penetrating the joints. Water remained on the surface of the joints.
