No. 1443186.0

SAMPLE DESCRIPTION:
Flooring Planks: Quick-Step Engineered Timber - Intenso.

ISO 4760:2022(E) - LAMINATE FLOORING – TOPICAL MOISTURE RESISTANCE – ASSEMBLED JOINT (MODIFIED)

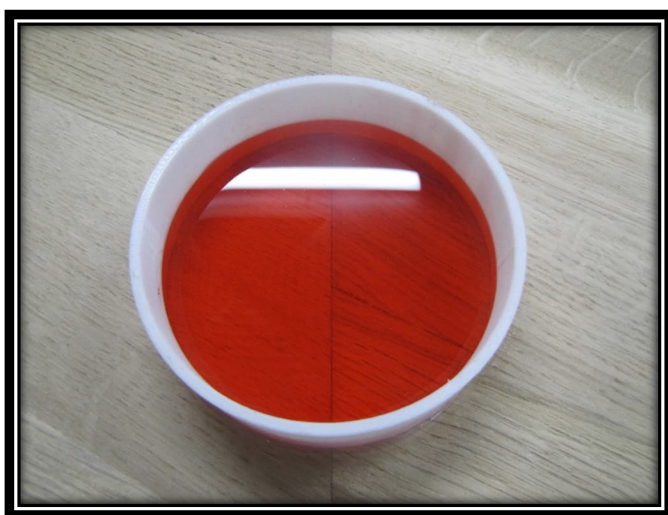
24 hrs With Water

Weights were placed on the outer corners of the test specimens to keep the samples flat throughout the test procedure. 100 mls of dye solution was applied onto the sample surface. It was poured into a cylinder 100mm diameter placed in the centre of the sample at the "T joint." Sealant was used at the plank/cylinder interface to avoid leakage.

The sample was placed on white paper towels prior to testing to enable detection of any dye penetration through the joints. The sample was left at 20°C, 65% Relative Humidity room conditions for 24 hours after the dye was added and then examined for dye penetration through the backing (not 23°C, 50% RH as stated in the method).

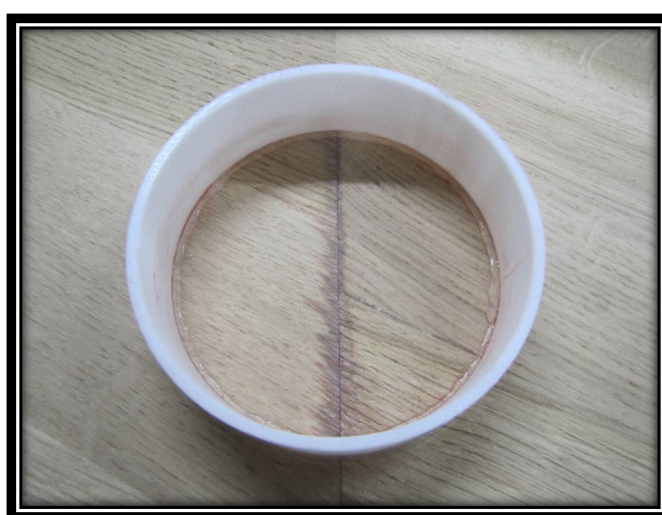
Wet Swell

Wet Swell			Recovered Swell		
	Specimen 1	Specimen 2	Specimen 3	Specimen 1	Specimen 2	Specimen 3
Qualitative Ratings (individual results):	1	1	1	1	1	1

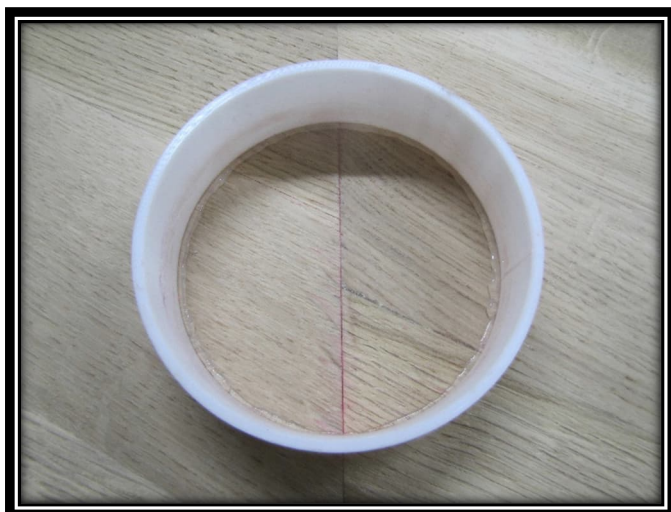
Recovered Swell

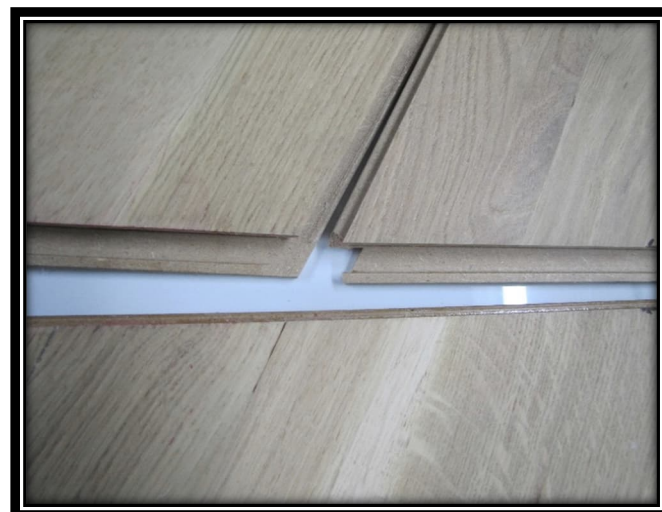
Recovered Swell (Disassembled)

Disassembly Observations:	Specimen 1	Specimen 2	Specimen 3
Migration of water along the upper surface:	No	No	No
Migration of water to the underside:	No	No	No
