**No. 1443185.2**

SAMPLE DESCRIPTION:  
Flooring Planks: Quick-Step Engineered Timber - Massimo.

**ISO 4760:2022(E) - LAMINATE FLOORING – TOPICAL MOISTURE RESISTANCE – ASSEMBLED JOINT (MODIFIED)**

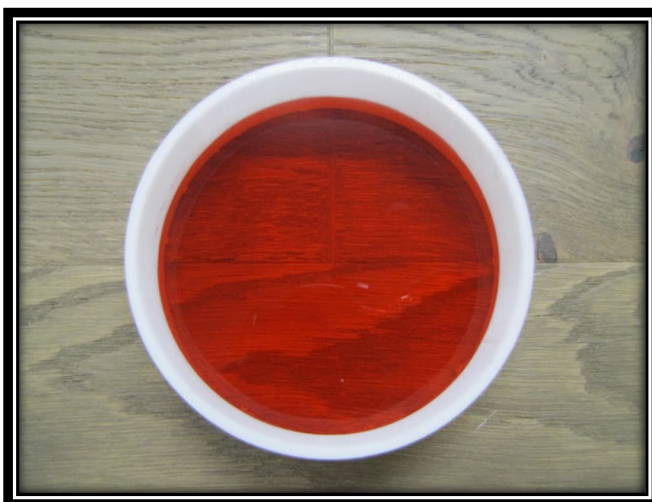
**24 hrs With Water**

Observations:	Specimen 1	Specimen 2	Specimen 3
Migration of water along the upper surface:	Yes	Yes	Yes
Migration of water to the underside:	No	No	No

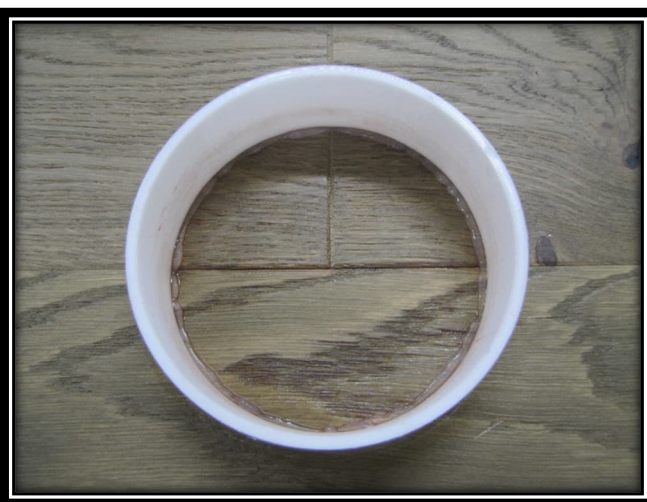
**Wet Swell**

Wet Swell			Recovered Swell		
	Specimen 1	Specimen 2	Specimen 3	Specimen 1	Specimen 2	Specimen 3
Qualitative Ratings (individual results):	1	1	1	1	1	1

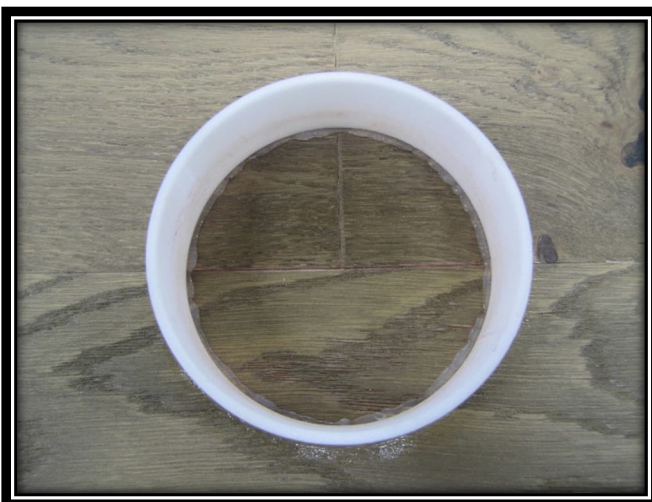
**Recovered Swell**
