No. 1425236.5I

SAMPLE DESCRIPTION:
Flooring sample – Quick Step Palazzo Engineered Timber
(PAL1342).

ISO 4760:2022(E) - LAMINATE FLOORING – TOPICAL MOISTURE RESISTANCE – ASSEMBLED JOINT (MODIFIED)

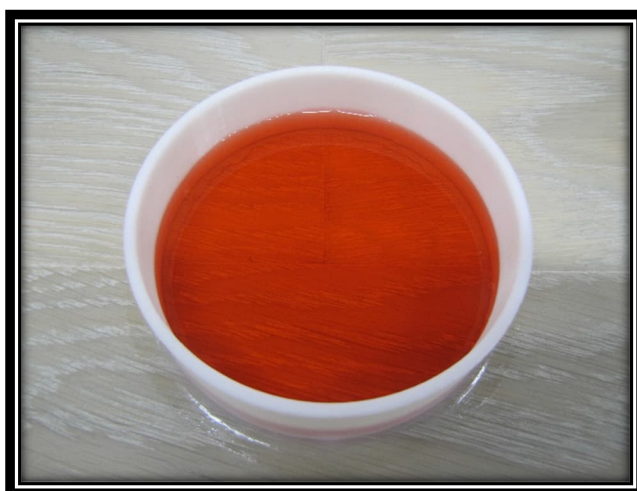
24 Hrs with Water

100 mls of dye solution was applied onto the sample surface. It was poured into a cylinder 100mm diameter placed in the centre of the sample at the "T joint." Sealant was used at the plank/cylinder interface to avoid leakage.

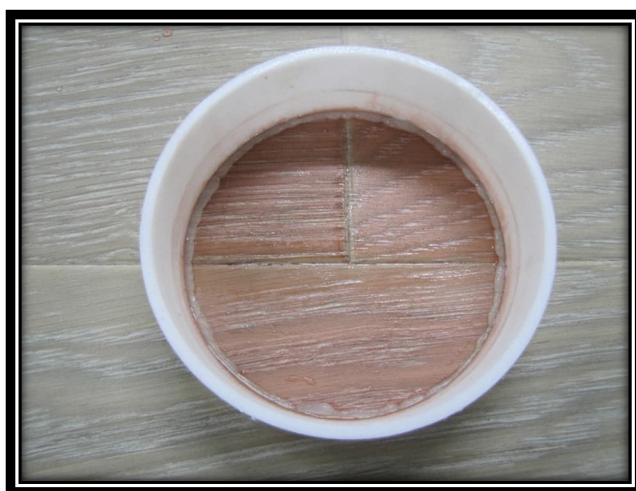
Wet Swell

Wet Swell		
	Specimen 1	Specimen 2	Specimen 3
Observations:	No Water Penetration through the joints.	No Water Penetration through the joints.	No Water Penetration through the joints.

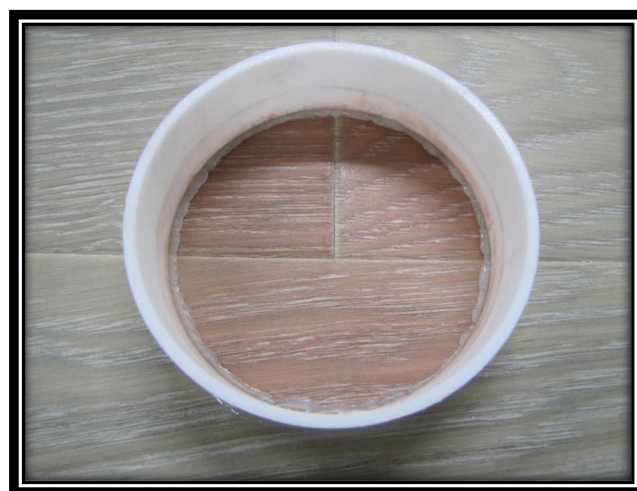
Recovered Swell

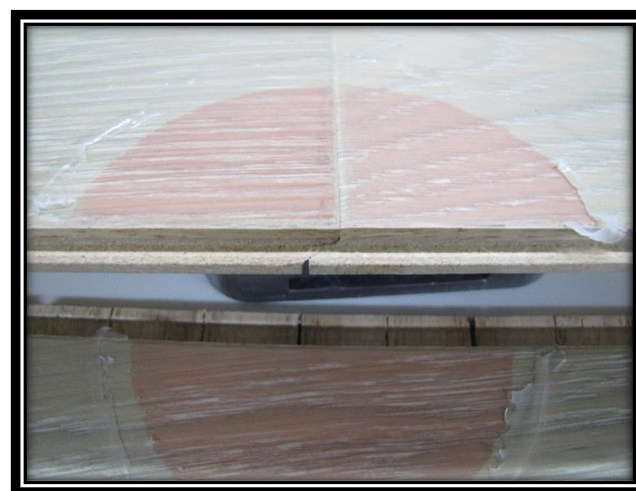
Recovered Swell (Disassembled)

Recovered Swell		
	Specimen 1	Specimen 2	Specimen 3
Disassembly Observations:	No evidence of water penetrating the joints. Water remained on the surface of the joints.	No evidence of water penetrating the joints. Water remained on the surface of the joints.	No evidence of water penetrating the joints. Water remained on the surface of the joints.
