**No. 1441387.6R**

SAMPLE DESCRIPTION:  
Flooring Planks: Quick-Step Perspective Nature Laminate.

**ISO 4760:2022(E) - LAMINATE FLOORING – TOPICAL MOISTURE RESISTANCE – ASSEMBLED JOINT (MODIFIED)**

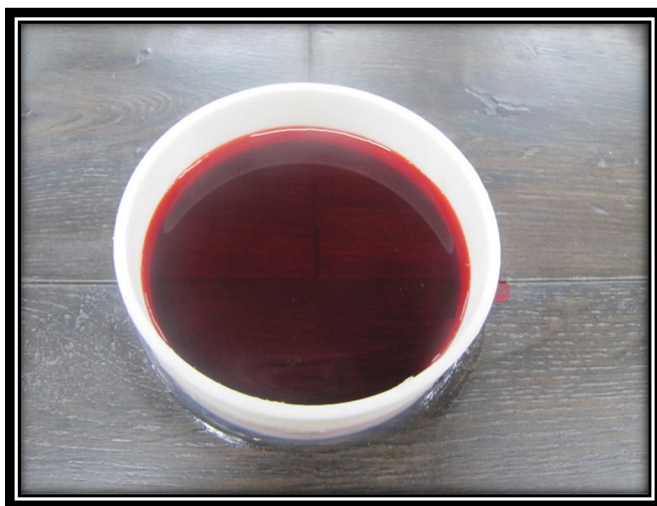
24 hrs With Water

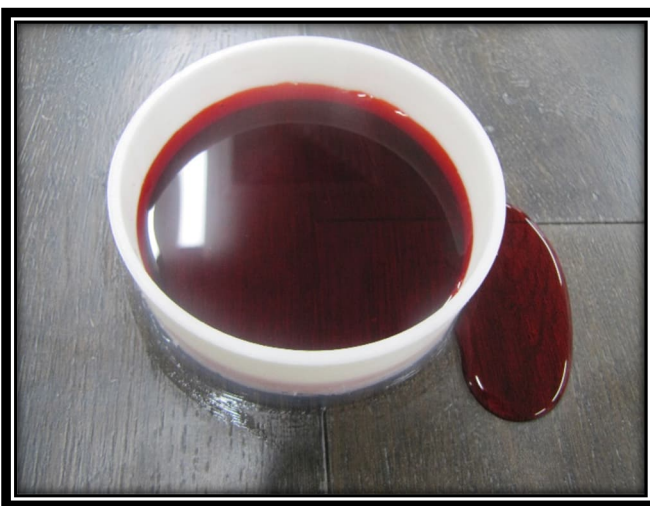
Samples 1 & 3 – Water channelled through the joints and puddle on the surface.

Observations:	Specimen 1	Specimen 2	Specimen 3
Migration of water along the upper surface:	Yes	No	Yes
Migration of water to the underside:	No	No	No
