**No. 1598436.2**

SAMPLE DESCRIPTION:  
Titan Vinyl Glue (Code TID173 – 2mm) flooring planks  
assembly adhered to a clear Perspex base using Uzin  
KE 68T adhesive.

**RESILIENT FLOOR COVERINGS (BASED ON ISO 4760:2022(E) - LAMINATE FLOORING – TOPICAL MOISTURE RESISTANCE – ASSEMBLED JOINT (MODIFIED))**

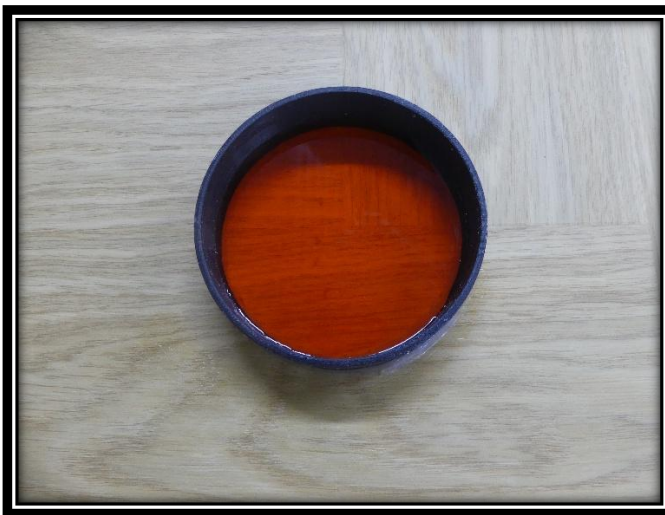
24 Hrs with Water

100 mls of dye solution was applied onto the sample surface. It was poured into a cylinder 100mm diameter placed in the centre of the sample at the “T joint.” Sealant was used at the plank/cylinder interface to avoid leakage.

The underside of the sample was inspected through the clear Perspex to enable detection of any dye penetration through the sample.

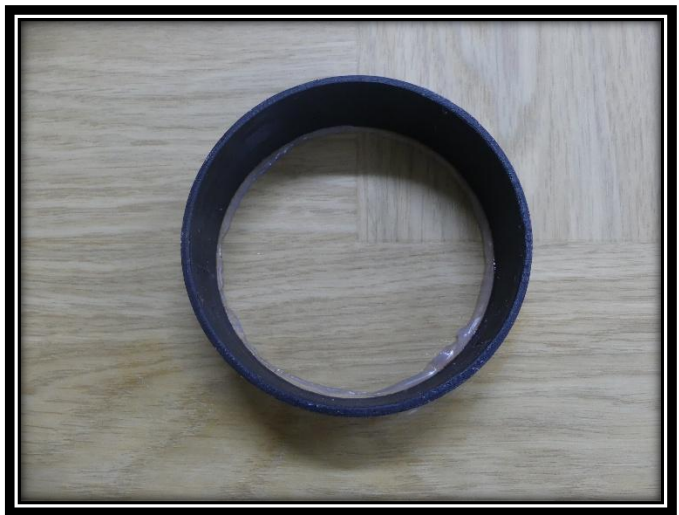
Wet Swell

| | Wet Swell | | | Recovered Swell | | |
|---|---|---|---|---|---|---|
| Qualitative Ratings<br>(individual results): | 1 | 1 | 1 | 1 | 1 | 1 |

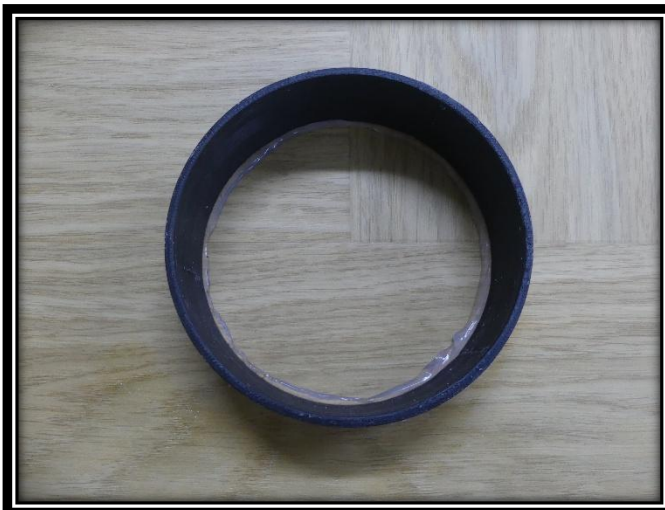
Recovered Swell

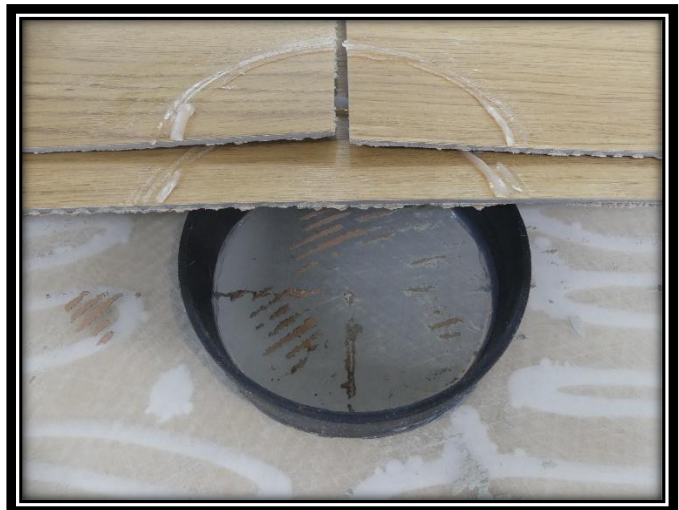
Recovered Swell (Disassembled)

| Disassembly Observations: | Specimen 1 | Specimen 2 | Specimen 3 |
|---|---|---|---|
| Migration of water along the upper surface: | No | No | No |
| Migration of water to the underside: | No | No | No |
