No. 1425236.5G

SAMPLE DESCRIPTION:
Flooring sample – Titan Rigid Hybrid (TIR178).

ISO 4760:2022(E) - LAMINATE FLOORING – TOPICAL MOISTURE RESISTANCE – ASSEMBLED JOINT (MODIFIED)

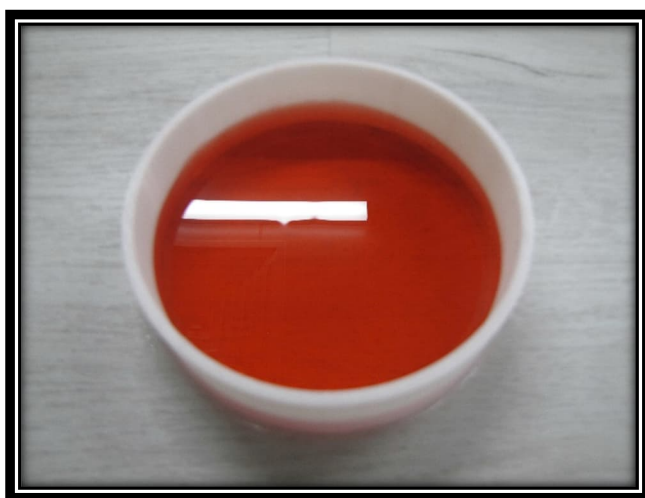
24 Hrs with Water

100 mls of dye solution was applied onto the sample surface. It was poured into a cylinder 100mm diameter placed in the centre of the sample at the "T joint." Sealant was used at the plank/cylinder interface to avoid leakage.

The sample was left at 20°C, 65% Relative Humidity room conditions for 24 hours after the dye was added and then examined for dye penetration through the backing (not 23°C, 50% RH as stated in the method).

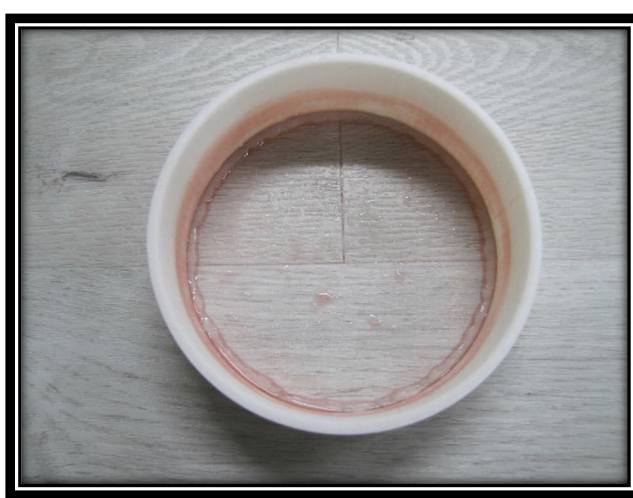
Wet Swell

Wet Swell		
	Specimen 1	Specimen 2	Specimen 3
Observations:	No Water Penetration through the joints.	No Water Penetration through the joints.	No Water Penetration through the joints.

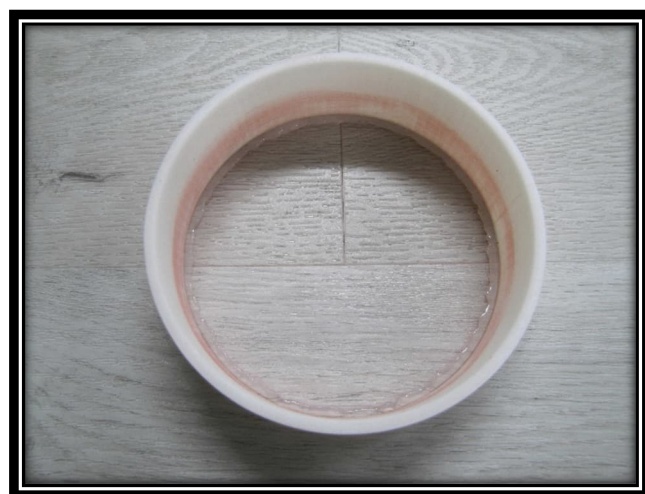
Recovered Swell

Wet Swell			Recovered Swell		
	Specimen 1	Specimen 2	Specimen 3	Specimen 1	Specimen 2	Specimen 3
Qualitative Ratings (individual results):	1	1	1	1	1	1

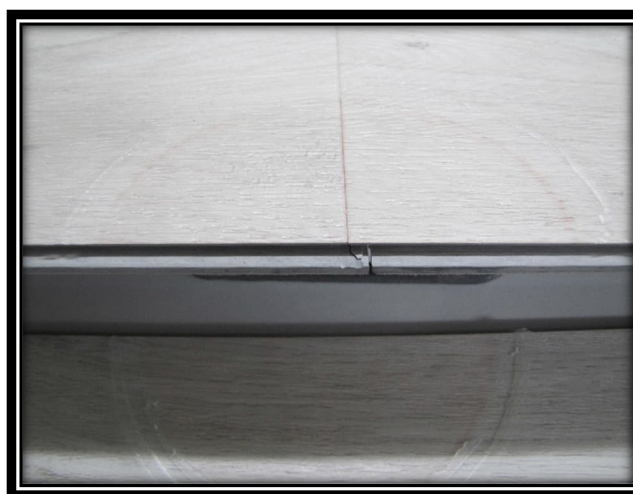
Recovered Swell (Disassembled)

Recovered Swell		
	Specimen 1	Specimen 2	Specimen 3
Disassembly Observations:	No evidence of water penetrating the joints. Water remained on the surface of the joints.	No evidence of water penetrating the joints. Water remained on the surface of the joints.	No evidence of water penetrating the joints. Water remained on the surface of the joints.
