**No. 1425236.5J**

SAMPLE DESCRIPTION:  
Flooring sample – Natures Oak Engineered Timber  
(WBO7008).

**ISO 4760:2022(E) - LAMINATE FLOORING – TOPICAL MOISTURE RESISTANCE – ASSEMBLED JOINT (MODIFIED)**

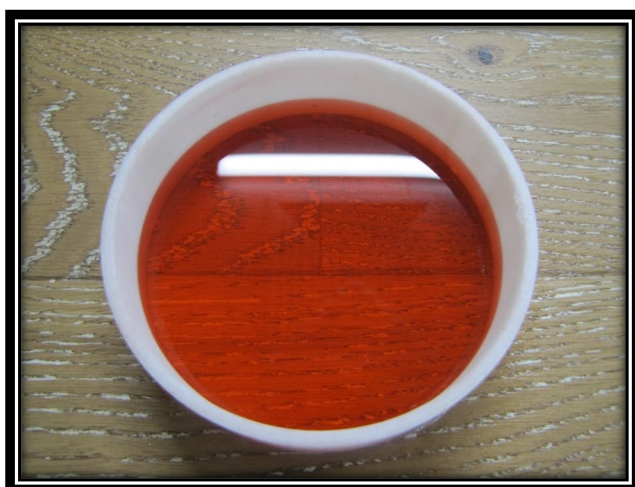
24 Hrs with Water

100 mls of dye solution was applied onto the sample surface. It was poured into a cylinder 100mm diameter placed in the centre of the sample at the "T joint." Sealant was used at the plank/cylinder interface to avoid leakage.

The sample was left at 20°C, 65% Relative Humidity room conditions for 24 hours after the dye was added and then examined for dye penetration through the backing (not 23°C, 50% RH as stated in the method).

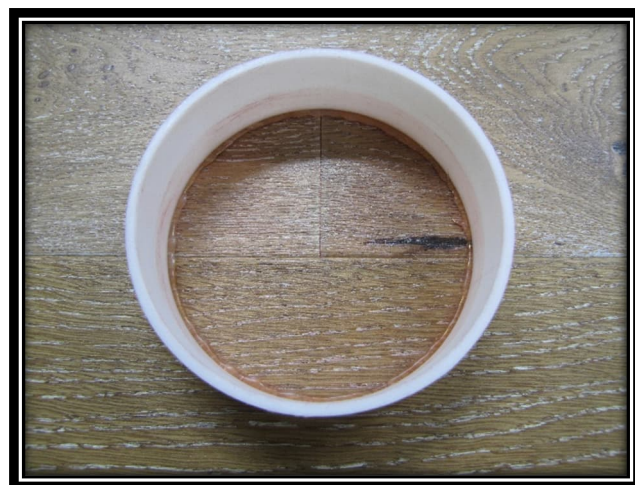
Recovered Swell

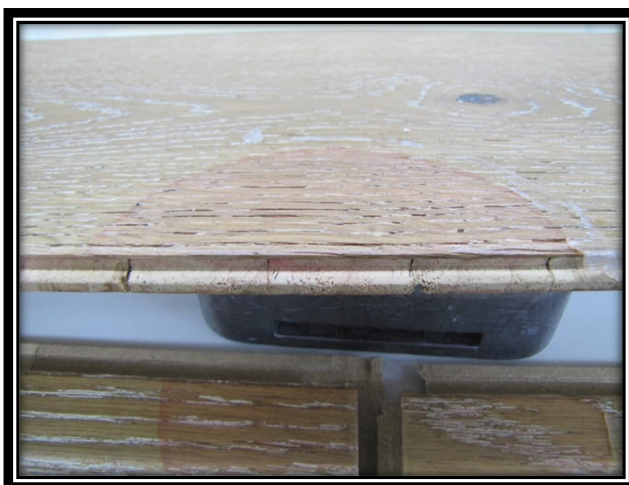
Recovered Swell (Disassembled)

Recovered Swell		
	Specimen 1	Specimen 2	Specimen 3
Disassembly Observations:	Noticeable water pooling on the joints. However, the water did not leak through to the underside of the planks.	Noticeable water pooling on the joints. However, the water did not leak through to the underside of the planks.	Noticeable water pooling on the joints. However, the water did not leak through to the underside of the planks.
