No. 1441846.1

SAMPLE DESCRIPTION:
Flooring Planks: Pergo Drammen Laminate.

ISO 4760:2022(E) - LAMINATE FLOORING – TOPICAL MOISTURE RESISTANCE – ASSEMBLED JOINT (MODIFIED)

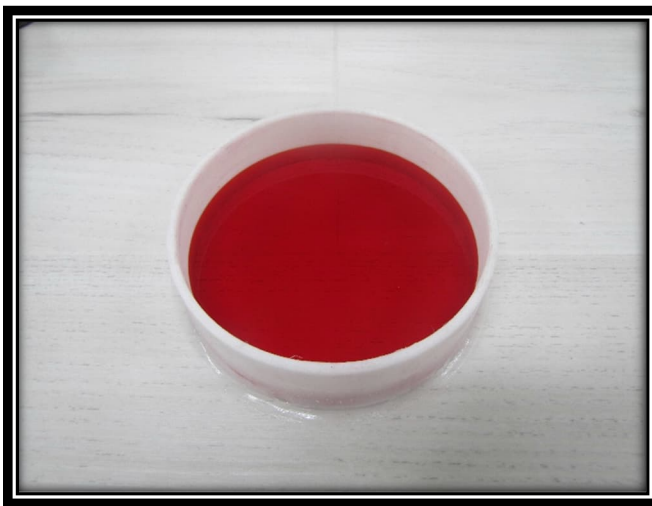
24 hrs With Water

Weights were placed on the outer corners of the test specimens to keep the samples flat throughout the test procedure. 100 mls of dye solution was applied onto the sample surface. It was poured into a cylinder 100mm diameter placed in the centre of the sample at the "T joint." Sealant was used at the plank/cylinder interface to avoid leakage.

The sample was placed on white paper towels prior to testing to enable detection of any dye penetration through the joints. The sample was left at 20°C, 65% Relative Humidity room conditions for 24 hours after the dye was added and then examined for dye penetration through the backing (not 23°C, 50% RH as stated in the method).

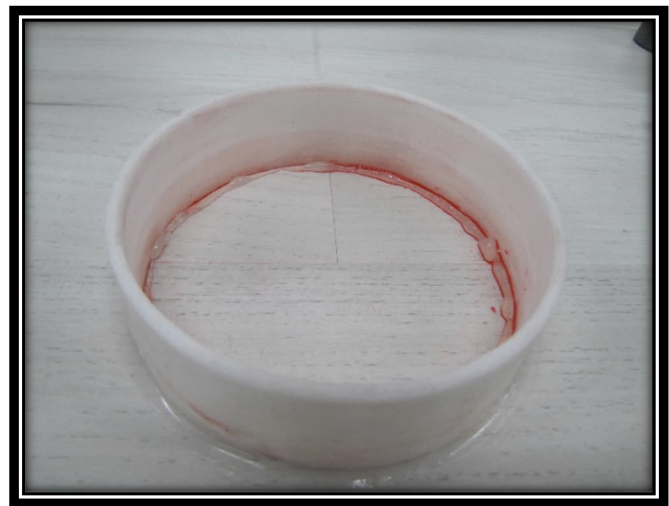
Wet Swell

Quantitative measurements are used to calculate surface swell in mm (within 15 minutes after water removal) and recovery swell (24 hours after removal of water).

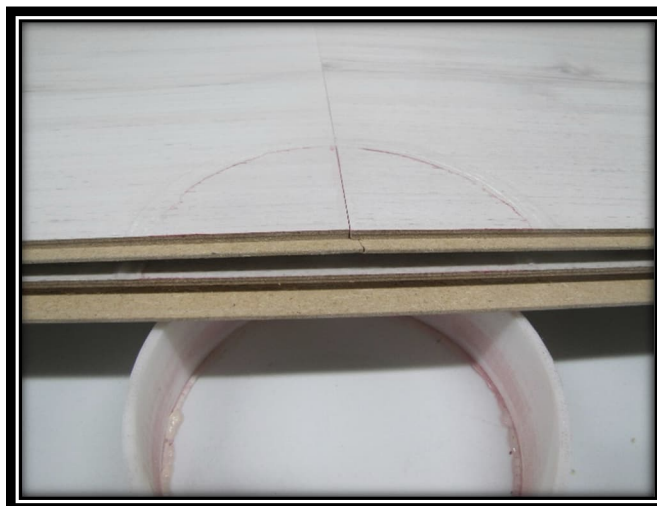
Recovered Swell (Disassembled)
