**No. 1443188.6**

SAMPLE DESCRIPTION:  
Flooring Planks: Pergo Hybrid – Glomma Pro.

**ISO 4760:2022(E) - LAMINATE FLOORING – TOPICAL MOISTURE RESISTANCE – ASSEMBLED JOINT (MODIFIED)**

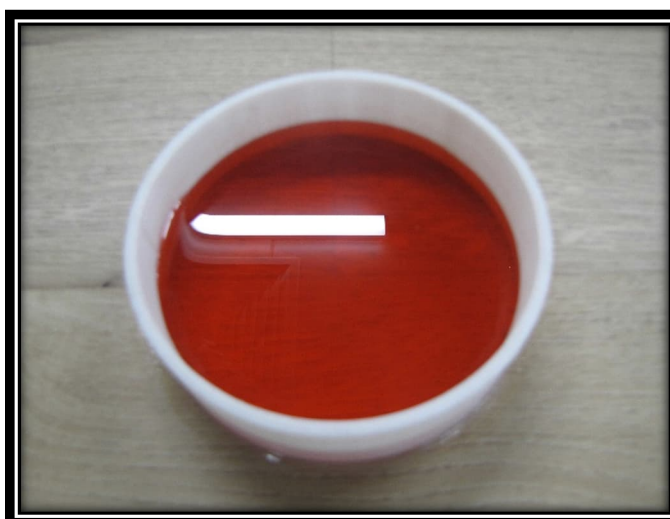
**24 hrs With Water**

Weights were placed on the outer corners of the test specimens to keep the samples flat throughout the test procedure. 100 mls of dye solution was applied onto the sample surface. It was poured into a cylinder 100mm diameter placed in the centre of the sample at the "T joint." Sealant was used at the plank/cylinder interface to avoid leakage.

The sample was placed on white paper towels prior to testing to enable detection of any dye penetration through the joints. The sample was left at 20°C, 65% Relative Humidity room conditions for 24 hours after the dye was added and then examined for dye penetration through the backing (not 23°C, 50% RH as stated in the method).

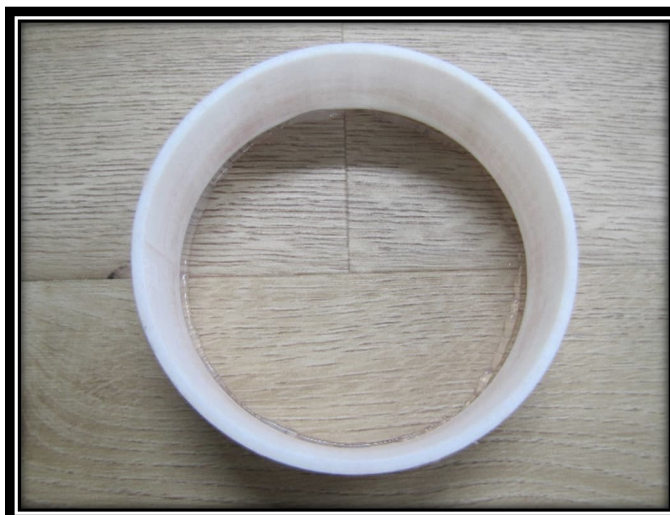
**Recovered Swell**

Quantitative measurements are used to calculate surface swell in mm (within 15 minutes after water removal) and recovery swell (24 hours after removal of water).
