**No. 1467246.3**

SAMPLE DESCRIPTION:  
Flooring Planks – Pergo Odense.

**ISO 4760:2022(E) - LAMINATE FLOORING – TOPICAL MOISTURE RESISTANCE – ASSEMBLED JOINT (MODIFIED)**

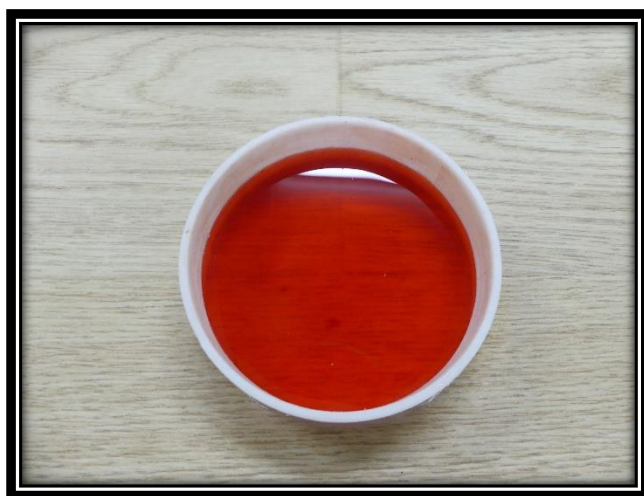
After 24 hrs With Water

100 mls of dye solution was applied onto the sample surface. It was poured into a cylinder 100mm diameter placed in the centre of the sample at the "T joint." Sealant was used at the plank/cylinder interface to avoid leakage.

The sample was left at 20°C, 65% Relative Humidity room conditions for 24 hours after the dye was added and then examined for dye penetration through the backing (not 23°C, 50% RH as stated in the method).

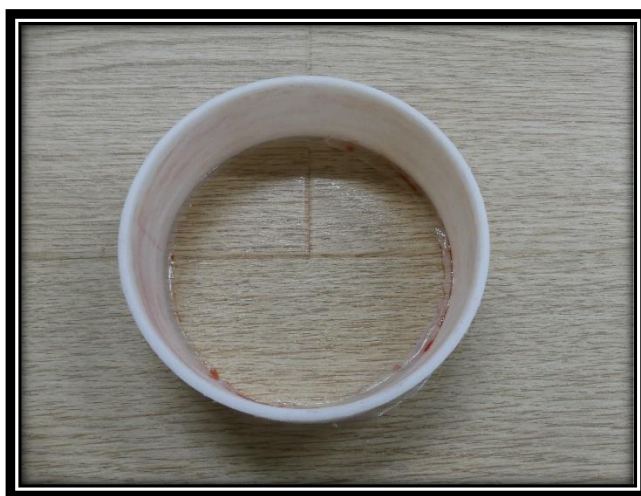
Wet Swell

- 1 = No change - Little to no noticeable change in edge swell or panel surface lift  
2 = Slight swelling - Slight swelling, small ridge along one or more joints, very little if any panel surface lift  
3 = Moderate - Noticeable edge swelling and some panel surface lift extending away from joint  
4 = Objectional - Severely raise edge and swelling extending noticeably under the panel surface  
5 = Failed test - Water leaked out of the ring, leaving no continuous film of water inside the ring  
(this grade is given even if there is no swell of the edge joint)

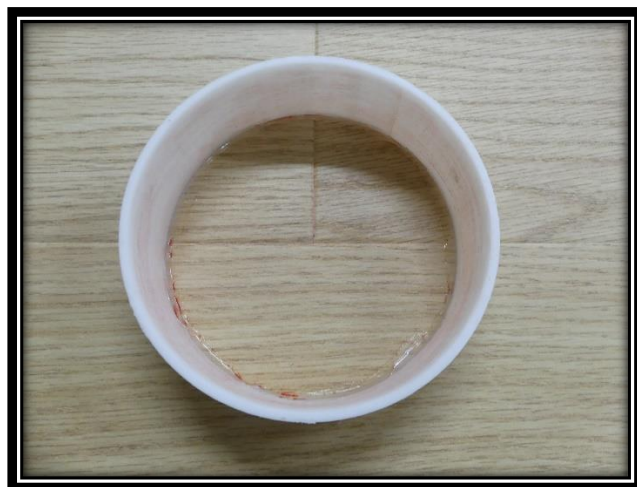
Recovered Swell
