**No. 1435598.6**

SAMPLE DESCRIPTION:  
Flooring Planks:  
Quick-Step Creo Hydroseal - Laminate

**ISO 4760:2022(E) - LAMINATE FLOORING – TOPICAL MOISTURE RESISTANCE – ASSEMBLED JOINT (MODIFIED)**

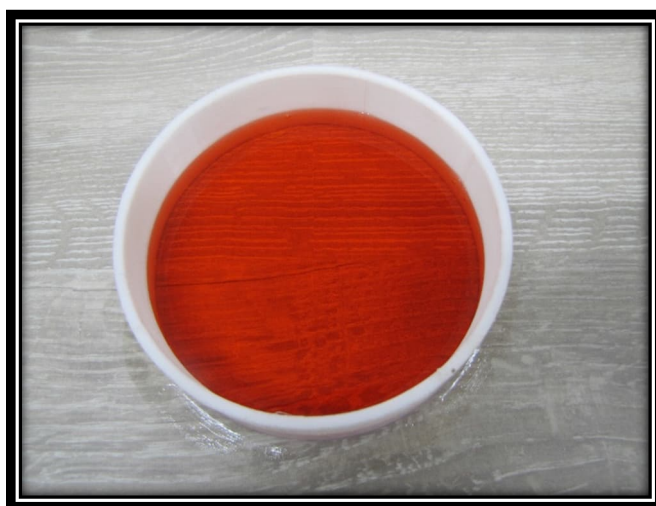
24 hrs With Water

Weights were placed on the outer corners of the test specimens to keep the samples flat throughout the test procedure. 100 mls of dye solution was applied onto the sample surface. It was poured into a cylinder 100mm diameter placed in the centre of the sample at the "T joint." Sealant was used at the plank/cylinder interface to avoid leakage.

The sample was placed on white paper towels prior to testing to enable detection of any dye penetration through the joints. The sample was left at 20°C, 65% Relative Humidity room conditions for 24 hours after the dye was added and then examined for dye penetration through the backing (not 23°C, 50% RH as stated in the method).

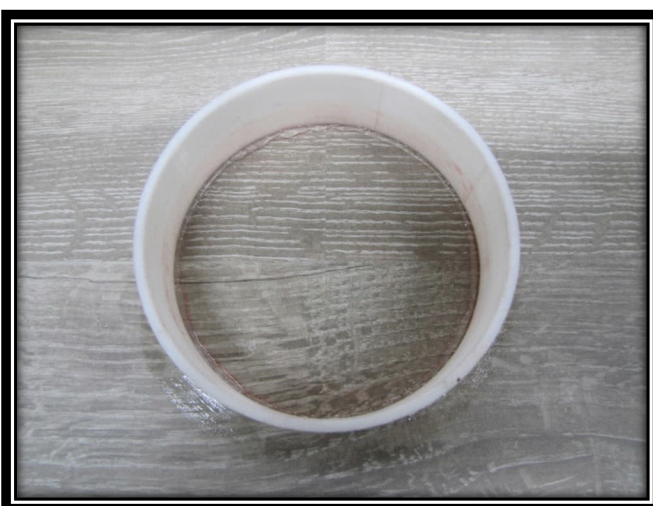
Wet Swell

- 1 = No change - Little to no noticeable change in edge swell or panel surface lift
- 2 = Slight swelling - Slight swelling, small ridge along one or more joints, very little if any panel surface lift
- 3 = Moderate - Noticeable edge swelling and some panel surface lift extending away from joint
- 4 = Objectional - Severely raise edge and swelling extending noticeably under the panel surface
- 5 = Failed test - Water leaked out of the ring, leaving no continuous film of water inside the ring (this grade is given even if there is no swell of the edge joint)

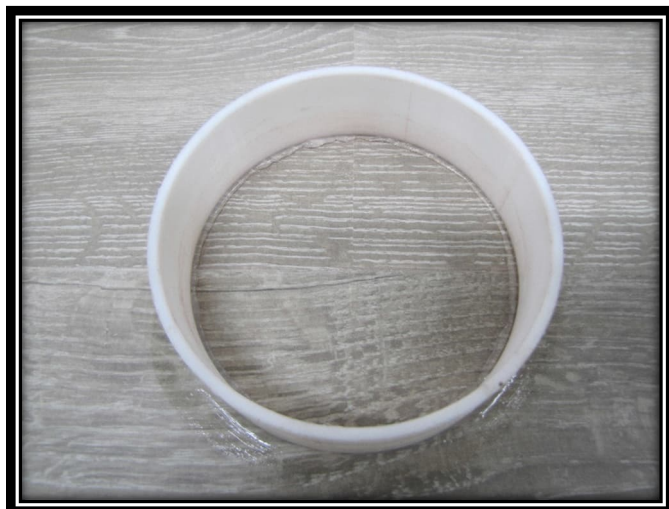
Recovered Swell

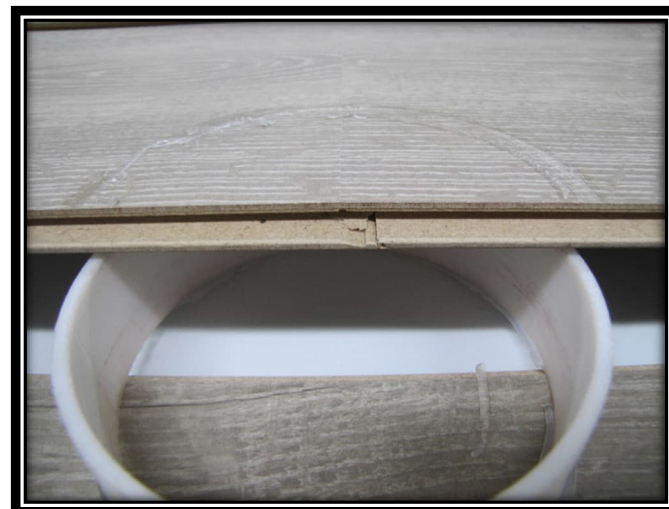
Recovered Swell (Disassembled)
