No. 1469218.0

SAMPLE DESCRIPTION:
Flooring Planks – Quick-Step ‘Faro’ Engineered Timber.

ISO 4760:2022(E) - LAMINATE FLOORING – TOPICAL MOISTURE RESISTANCE – ASSEMBLED JOINT (MODIFIED)

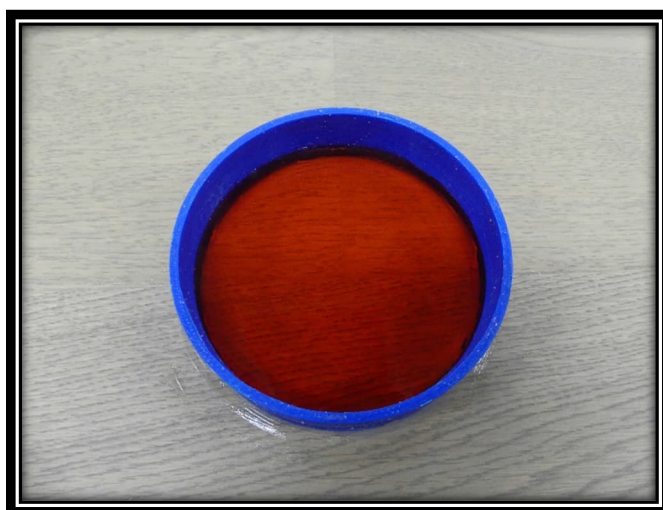
After 24 hrs With Water

100 mls of dye solution was applied onto the sample surface. It was poured into a cylinder 100mm diameter placed in the centre of the sample at the "T joint." Sealant was used at the plank/cylinder interface to avoid leakage.

The sample was left at 20°C, 65% Relative Humidity room conditions for 24 hours after the dye was added and then examined for dye penetration through the backing (not 23°C, 50% RH as stated in the method).

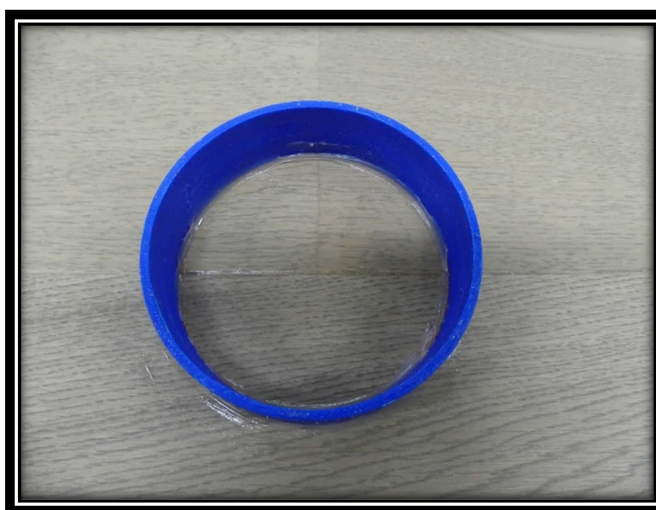
Wet Swell

- 1 = No change - Little to no noticeable change in edge swell or panel surface lift
- 2 = Slight swelling - Slight swelling, small ridge along one or more joints, very little if any panel surface lift
- 3 = Moderate - Noticeable edge swelling and some panel surface lift extending away from joint
- 4 = Objectional - Severely raise edge and swelling extending noticeably under the panel surface
- 5 = Failed test - Water leaked out of the ring, leaving no continuous film of water inside the ring (this grade is given even if there is no swell of the edge joint)

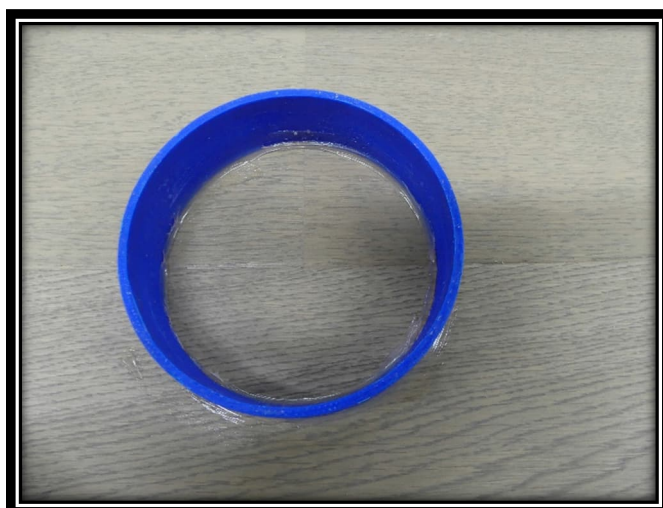
Recovered Swell

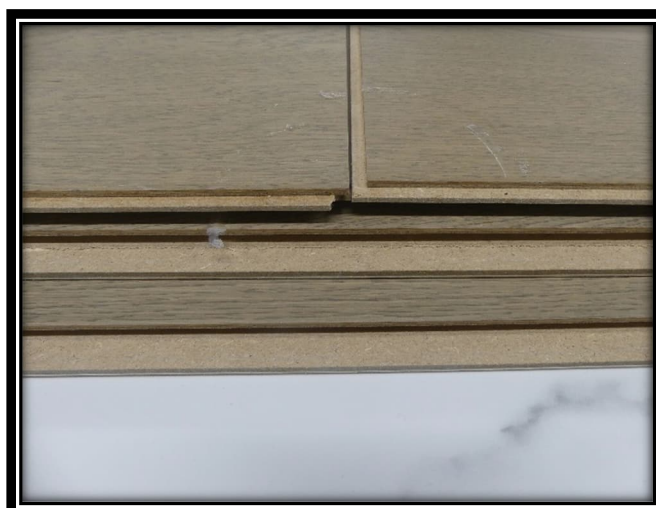
Recovered Swell (Disassembled)
