No. 1463480.2

SAMPLE DESCRIPTION:
Flooring Planks – Quick Step Muse

ISO 4760:2022(E) - LAMINATE FLOORING – TOPICAL MOISTURE RESISTANCE – ASSEMBLED JOINT (MODIFIED)

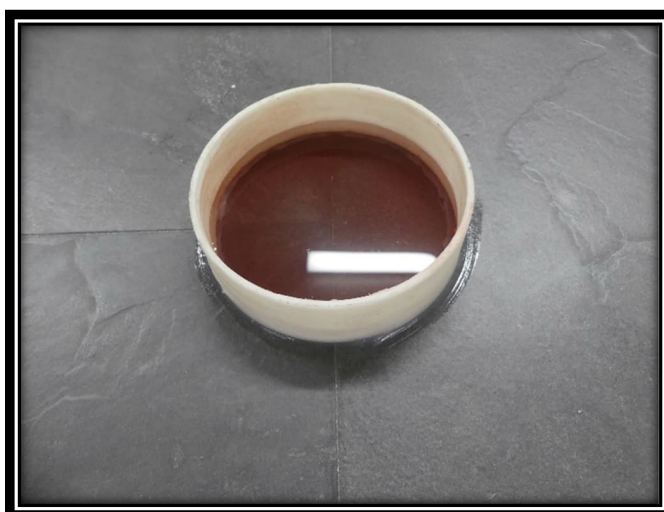
After 24 hrs With Water

100 mls of dye solution was applied onto the sample surface. It was poured into a cylinder 100mm diameter placed in the centre of the sample at the "T joint." Sealant was used at the plank/cylinder interface to avoid leakage.

The sample was left at 20°C, 65% Relative Humidity room conditions for 24 hours after the dye was added and then examined for dye penetration through the backing (not 23°C, 50% RH as stated in the method).

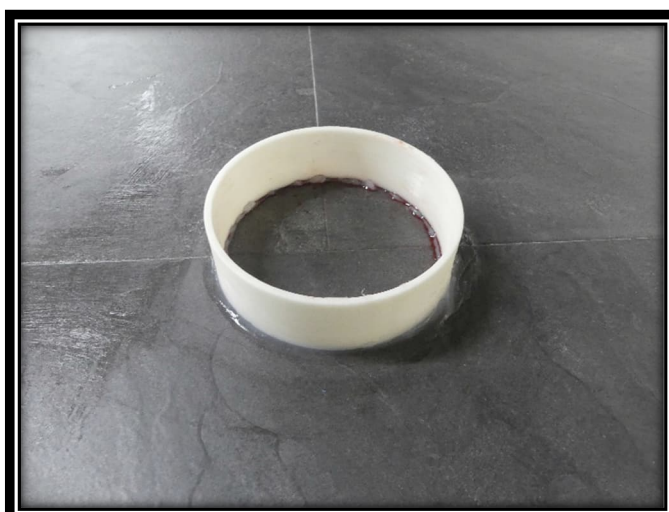
Wet Swell

- 1 = No change - Little to no noticeable change in edge swell or panel surface lift
 2 = Slight swelling - Slight swelling, small ridge along one or more joints, very little if any panel surface lift
 3 = Moderate - Noticeable edge swelling and some panel surface lift extending away from joint
 4 = Objectional - Severely raise edge and swelling extending noticeably under the panel surface
 5 = Failed test - Water leaked out of the ring, leaving no continuous film of water inside the ring
 (this grade is given even if there is no swell of the edge joint)

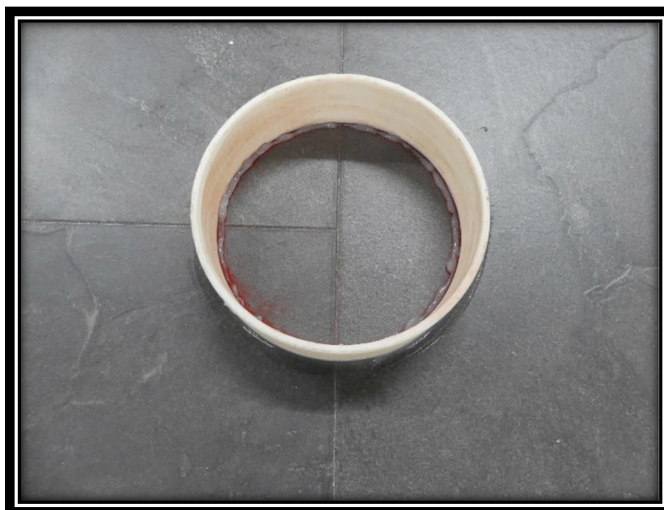
Recovered Swell

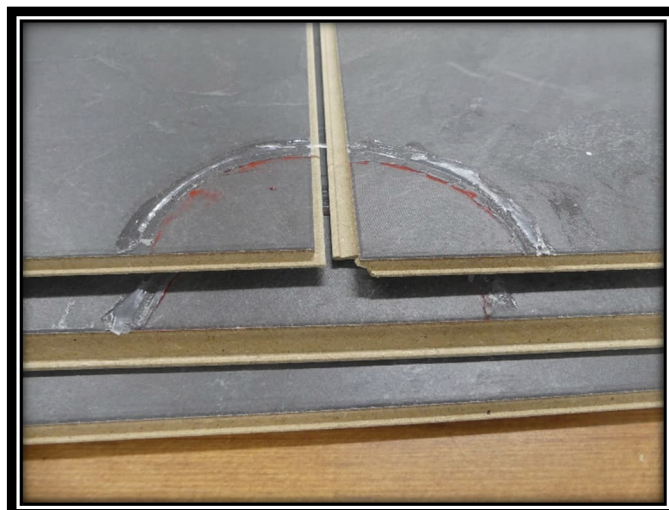
Recovered Swell (Disassembled)
